RAILROAD EXPERIENCE WITH A TURBOCHARGED TWO CYCLE DIESEL ENGINE

ROSS C. HILL

Union Pacific Railroad Company

For presentation at the
SAE NATIONAL WEST COAST MEETING
Mark Hopkins Hotel, San Francisco, California
August 6-8, 1956

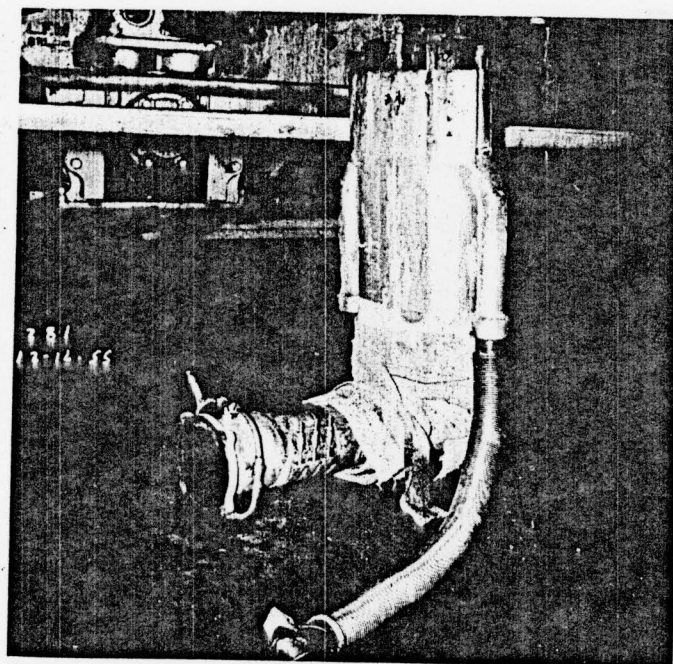
Initial standing tests showed that better engine sealing was required. The standard engine operates with zero to slightly negative crankcase pressure. The turbocharged engine had positive pressure of approximately 6 inches of water. Cylinder liner seals were improved and four exhaust aspirated vents were added to the rocker box covers. See Fig. 7.

FIG. 7 EXHAUST STACK WITH CRANKCASE EXHAUSTERS

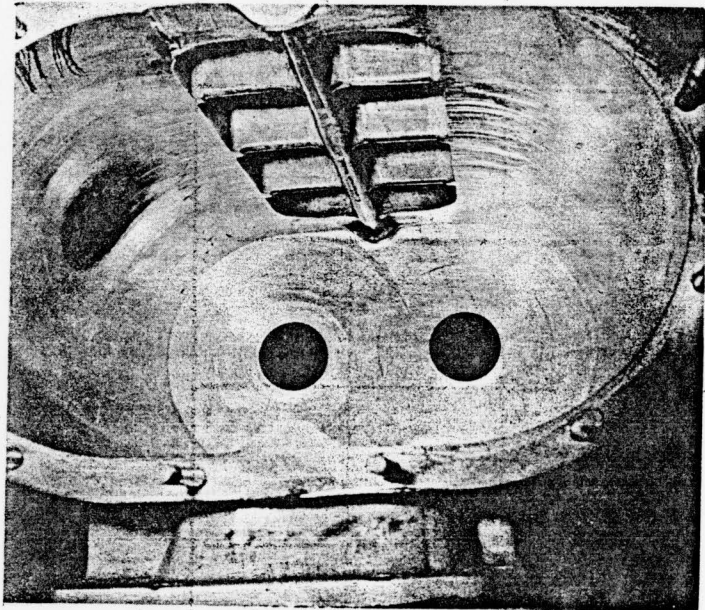
The unit was then connected to load through its own dynamic braking resistors and taken out for standing tests at various altitudes up to 4000 feet. Following completion of the standing tests it was placed in helper service out of San Bernardino, California. After about five trips the roots blowers failed and it was necessary to replace them. Inspection of the failure showed that the aluminum rotors rubbed on the case at the inlet due to differential expansion. Rotor length expansion also caused rubbing at the end opposite thrust bearings. As an expedient the rubbing was eliminated by turning down rotor diameter and shimming the thrust bearing end of the rotors. Blower clearances on the standard engine are very sensitive and have been increased between the B and C model engines. Fig. 8 shows the interior of a failed blower case and Fig. 9 shows one of the rotors.

FIG. 8 FAILED BLOWER CASE

It was then learned from the builder that a large part of the air leakage could be traced to the blower shaft seals. These were reversed and the crankcase pressure dropped to a respectable figure. Development of a double lip seal is under way.

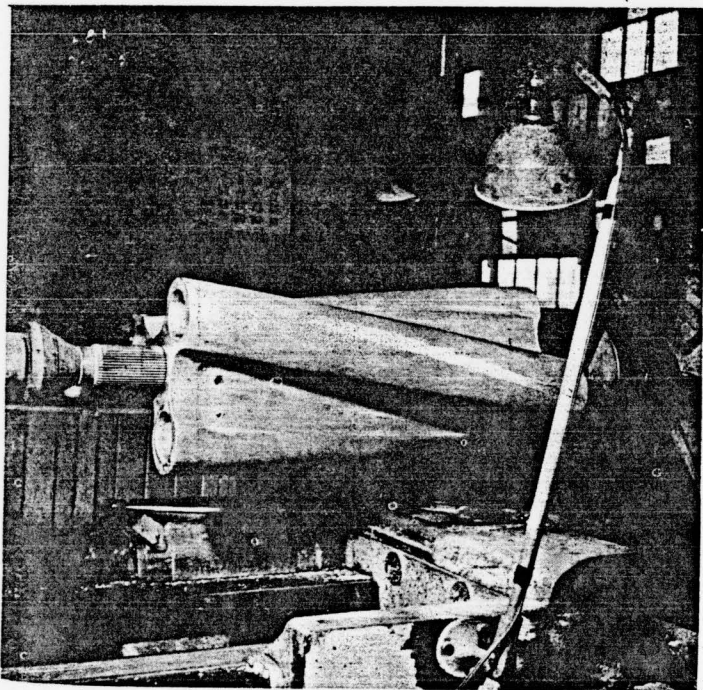
FIG. 9 FAILED BLOWER ROTOR
