# Union Pacific E8 #942

Restoration project at Orange Empire  
Railway Museum Perris, CA  
2011/2012

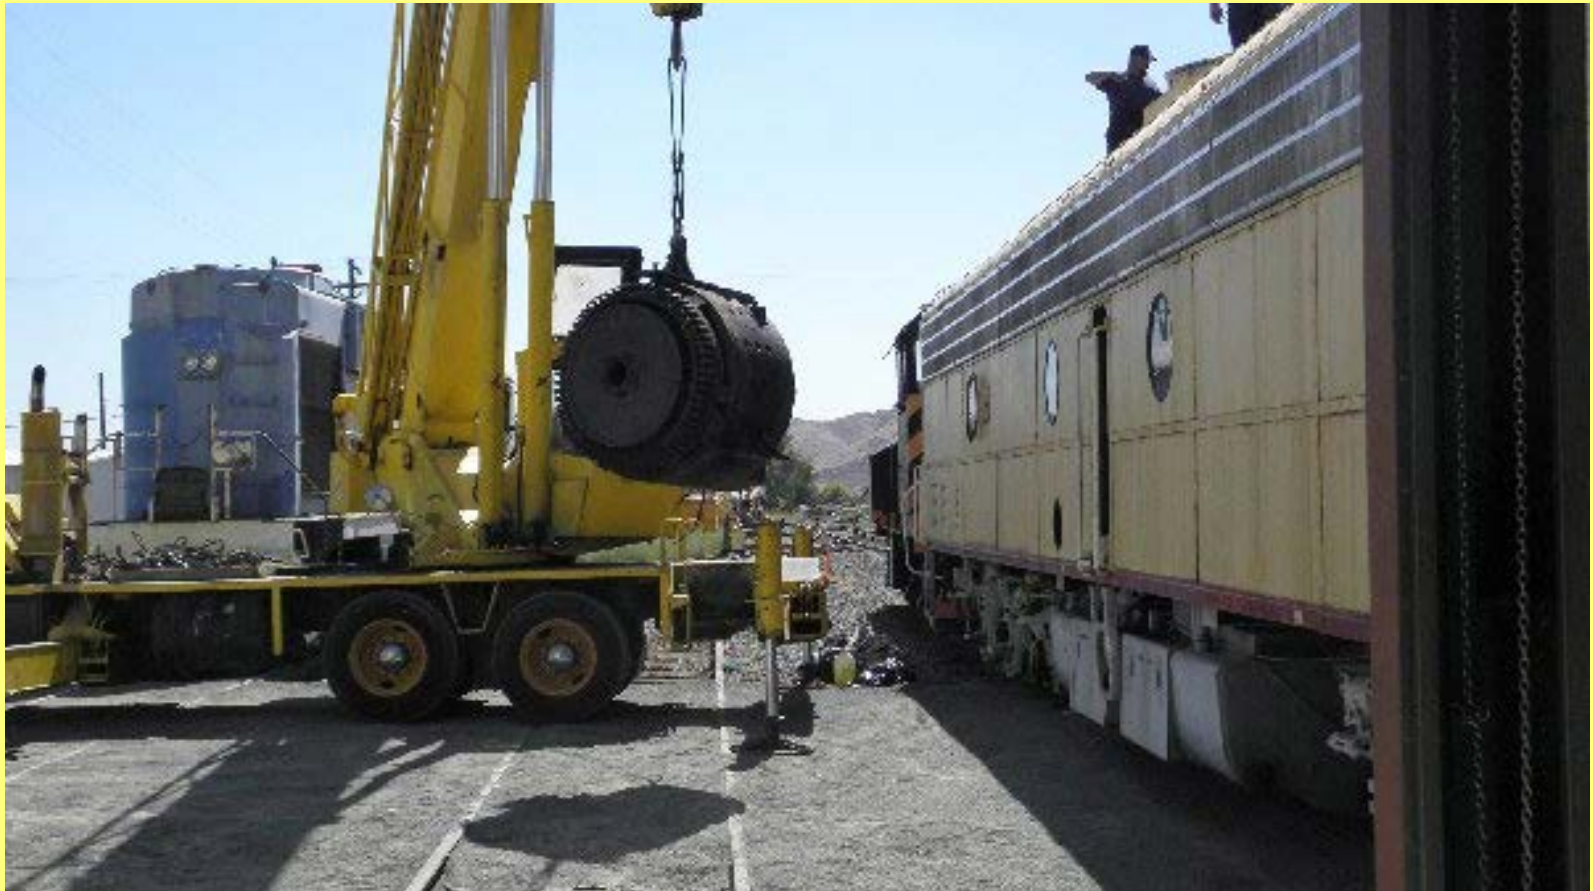
Taking out the main generator required a lot of work, there were large parts that needed to be removed and connections that needed to be un done in such a way that when the generator was put back in everything would line up properly. Here is the generator after being pulled out of U.P. 942. The main generator is a D15 and is connected to a D16 companion alternator that makes 3 phase variable frequency, variable voltage for the cooling fans. They are tied together and weigh 11,000 lbs.

Here the generator is loaded onto a flatbed trailer and ready for the trip to Lyons, Kansas where it will be rebuilt. At this point the museum was not entirely sure of the extent of the damage and were hopeful that there wasn't enough wrong to prevent a successful rebuild.

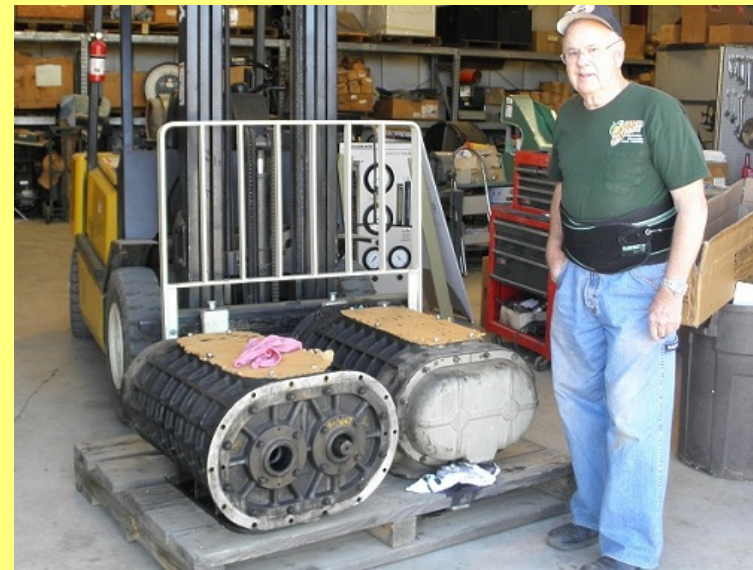
While the main generator was out a mechanical check revealed that the blowers that supply air to the prime movers were in poor shape. The museum had a spare set but they were not usable. Fortunately the museum has a volunteer who was able to arrange to exchange the blowers on hand for a rebuilt set in excellent condition.

Here Frank Kunsaitis and Dwayne Dame inspect the blowers that were on hand at OERM.

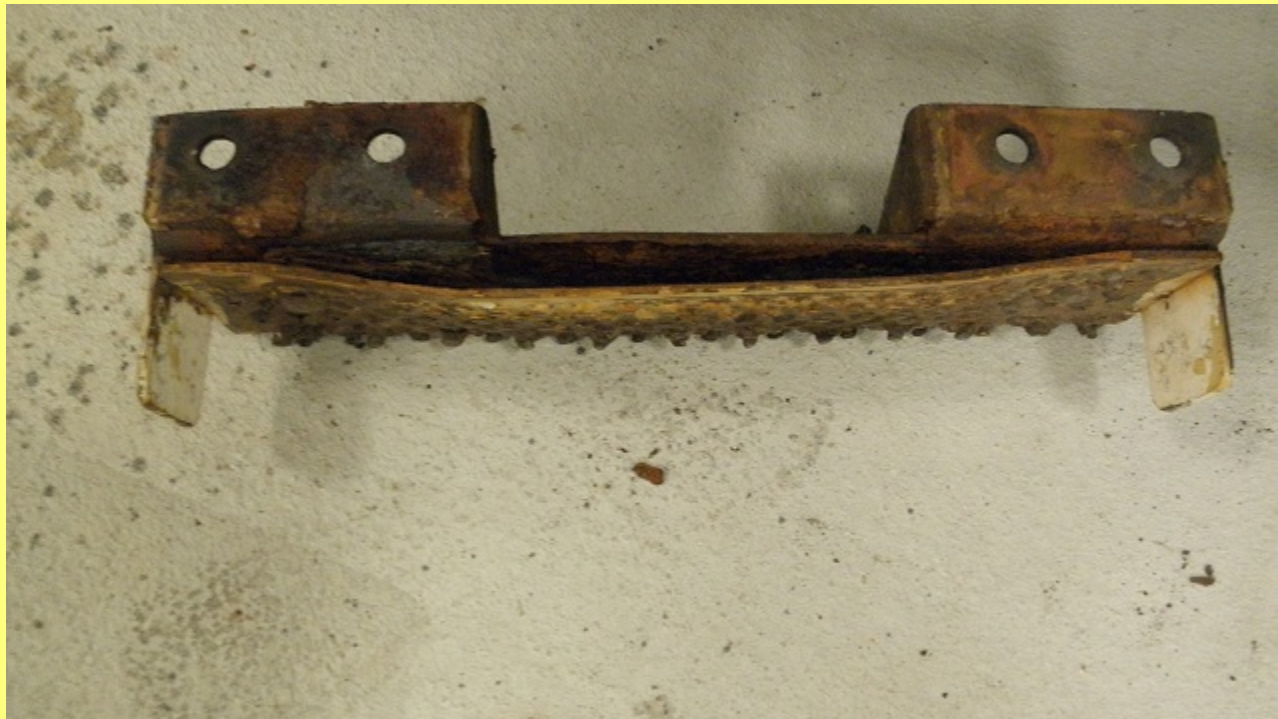
In the many years that have passed since U.P. 942 left the EMD plant in LaGrange, IL the elements have left their mark in the form of rust in every conceivable area, visible and not. In many places the rust expanded and caused metal parts to bow and become distorted. Here is a step that clearly illustrates this problem.

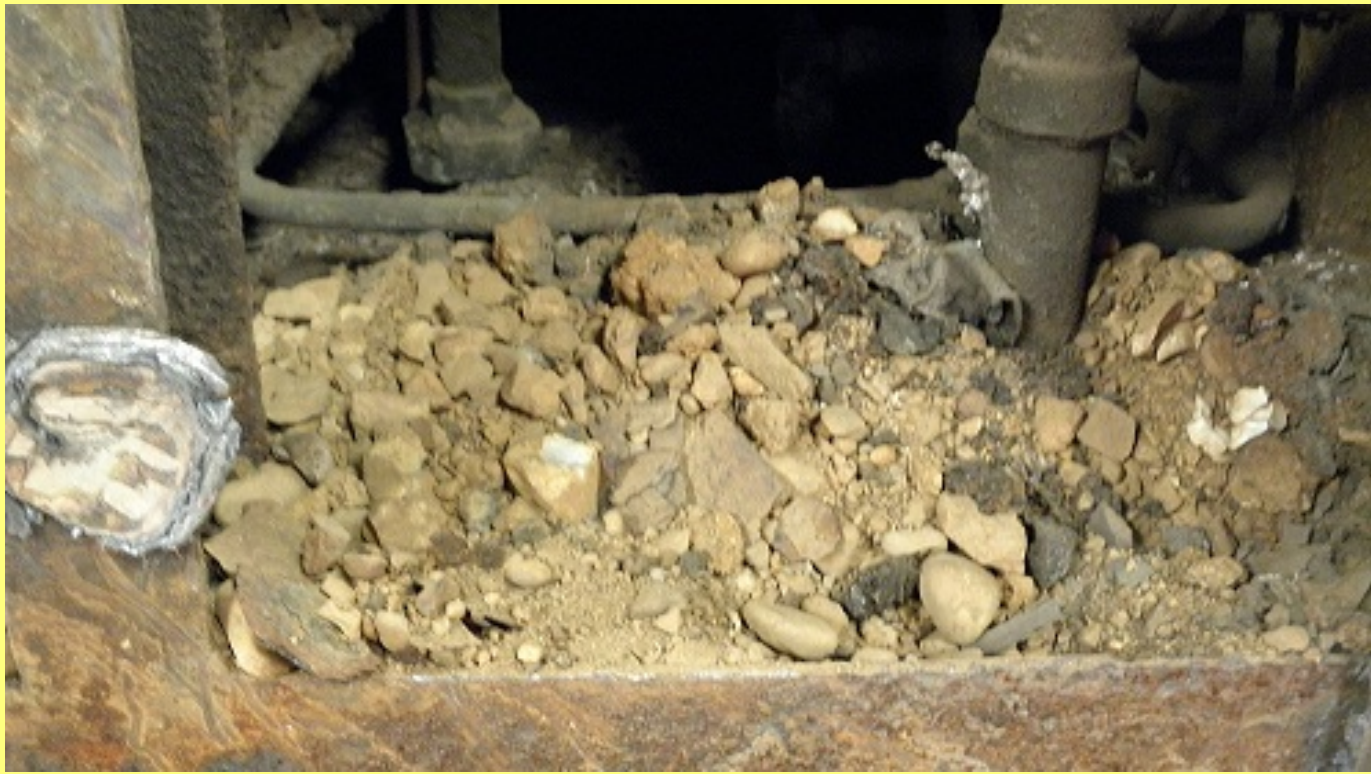
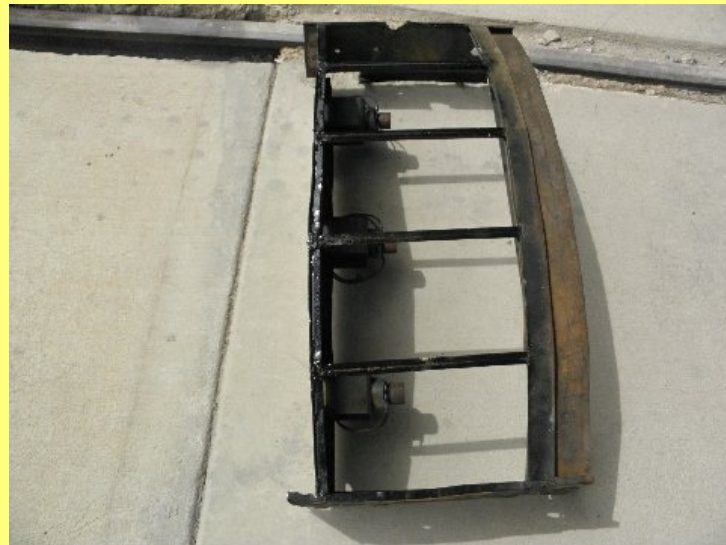
One of the more interesting discoveries came about when the rusted metal on the right side of the locomotive under the cab was removed. When the old metal was cut away we found a large amount of rocks and dirt just inside in an area that would not have normally been accessed. At first we could see no explanation for this, but as it was discussed the only thing we could come up with was that at some point in time U.P. 942 suffered some sort of accident. Should this have occurred the side of the locomotive could have been opened up allowing the rocks and dirt inside then for what ever reason repaired without removing the debris. Later we also found that the number board on that side had been damaged then hastily repaired, which added to our suspicions. If is this the case we were not able to find out any information that would verify our theory. So, without any proof as to what really happened the bent number board plus rocks and dirt found inside the locomotive will remain a mystery.

Here is what we found.....

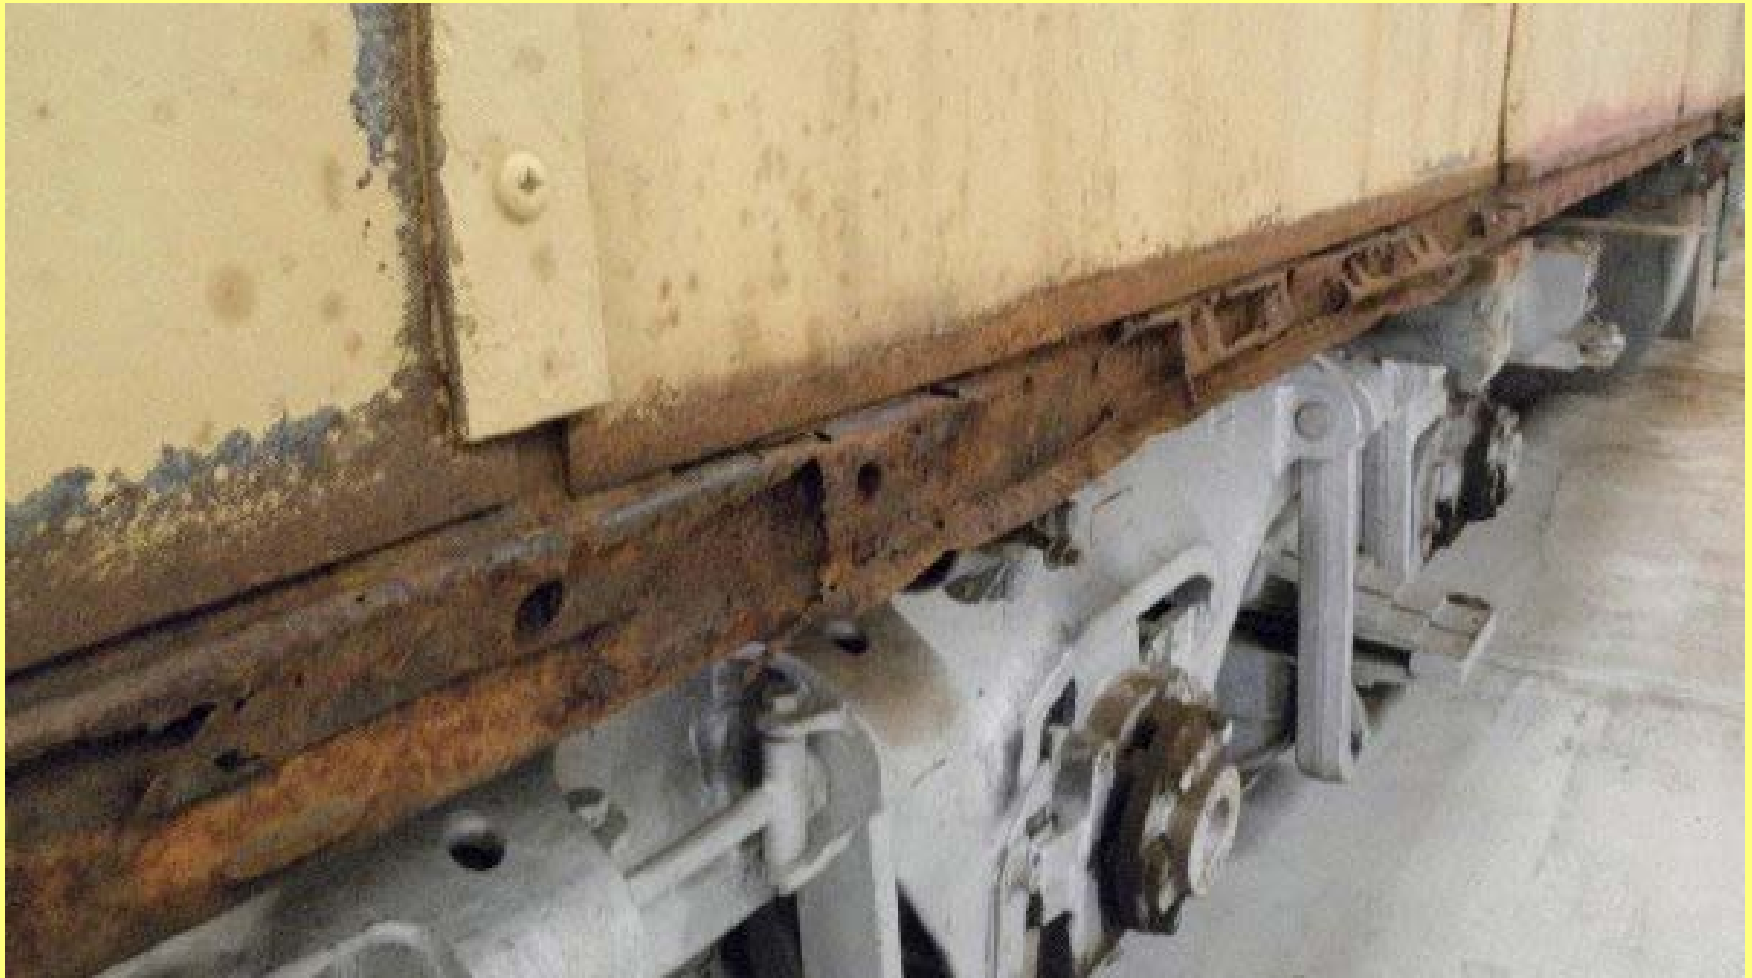
When U.P. 942 came to OERM the rub rail on both sides showed obvious signs of fatigue and we knew that when we removed these pieces it wasn't going to be pretty. So, we were not surprised when we found this.....

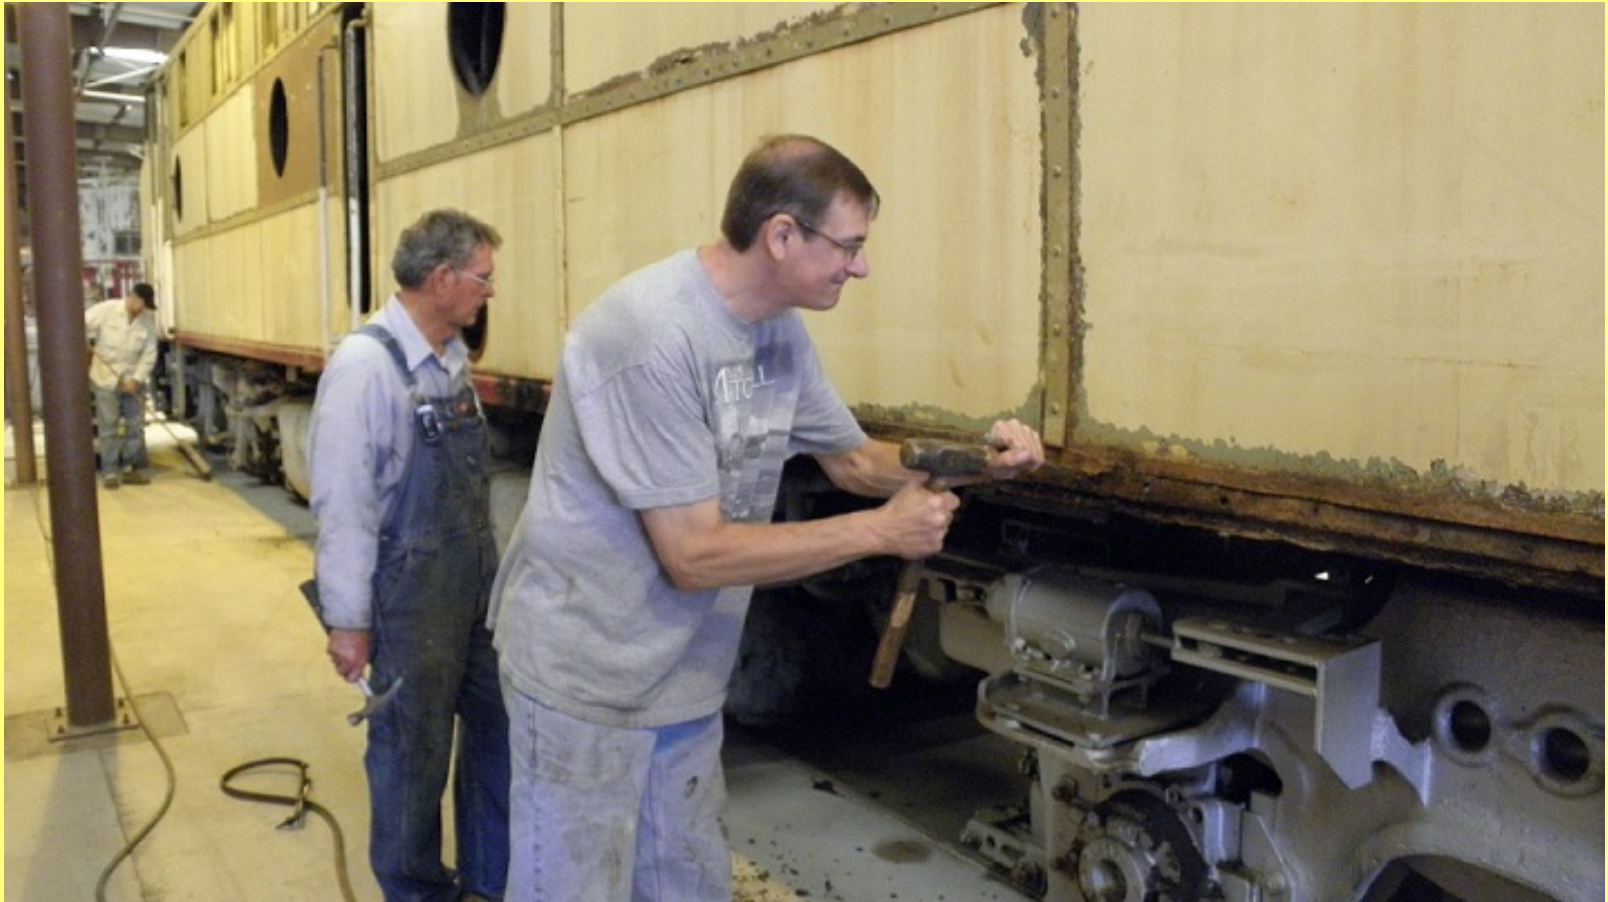
Underneath the rub rail sections there is a channel attached to the frame, which has threaded inserts used to bolt the rub rails to the locomotive. What was left of this channel was so badly rusted that there was no way to reuse it. Air chisels and elbow grease were used to remove the old channel so that new ones could be installed.

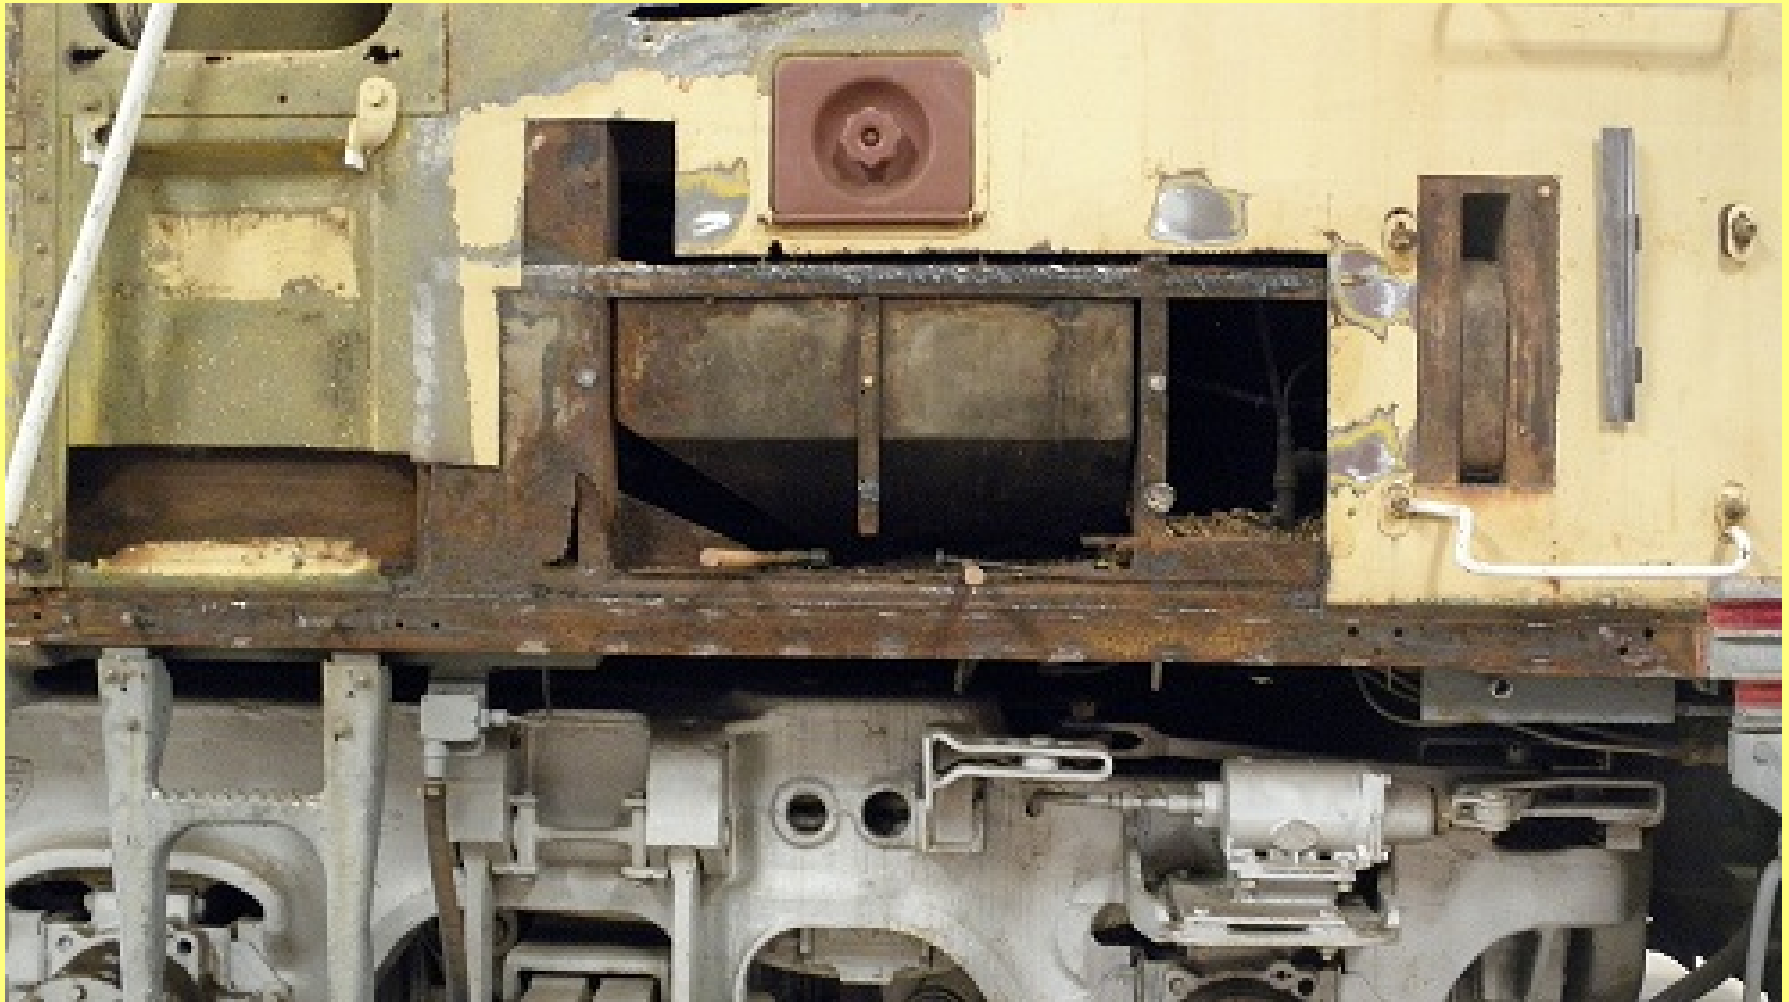
There were many other areas beside the rub rails where the carbody needed some pretty serious attention. The engineers side, under the cab, required quite a bit of reworking. Here is what U.P. 942 looked like after the bad spots had been cut out.

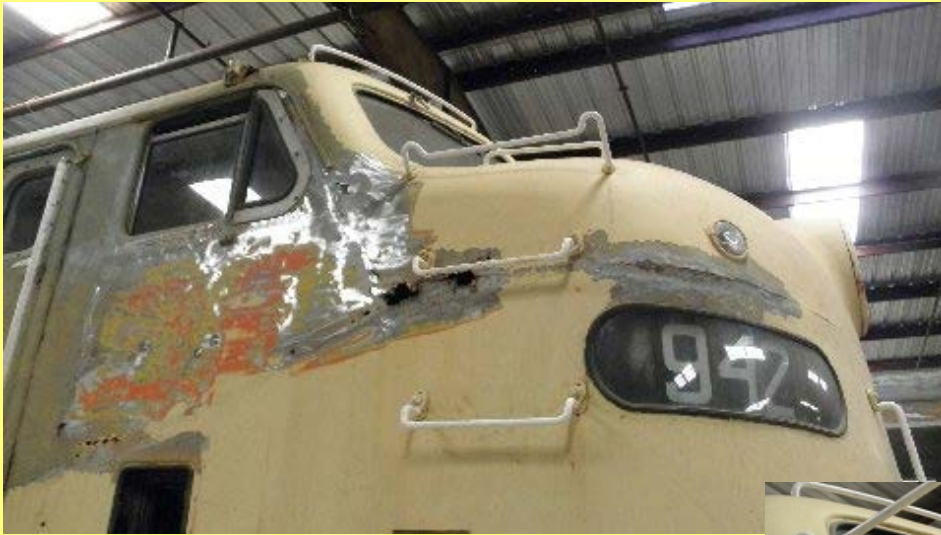
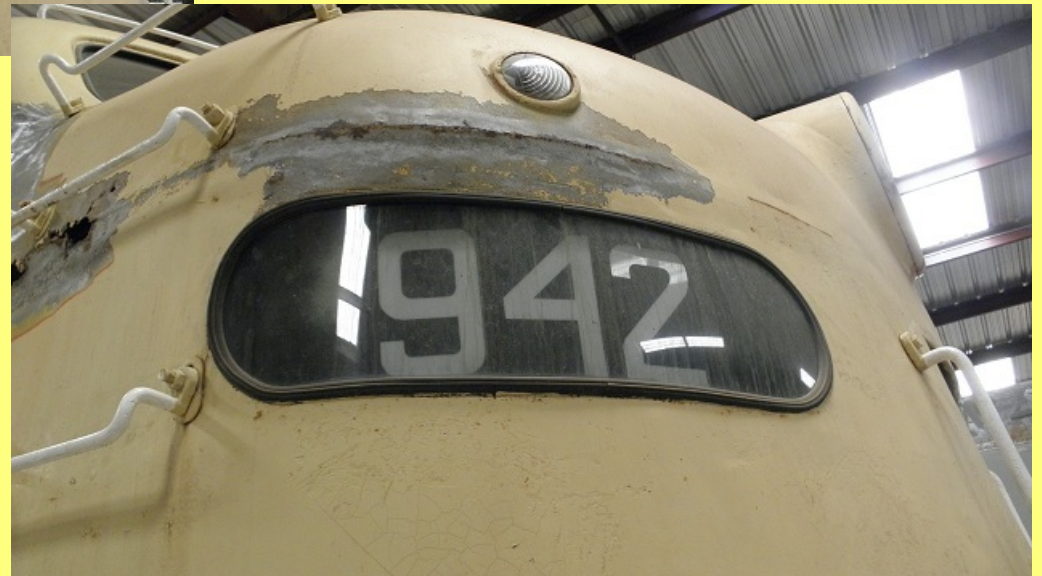
The nose of U.P. 942 was another place that needed to be addressed. At EMD the rounded areas were shaped with lead so the crack and rusted out area couldn't be welded closed. Fortunately body fillers used today are very strong and the repair work done here will not suffer from age.

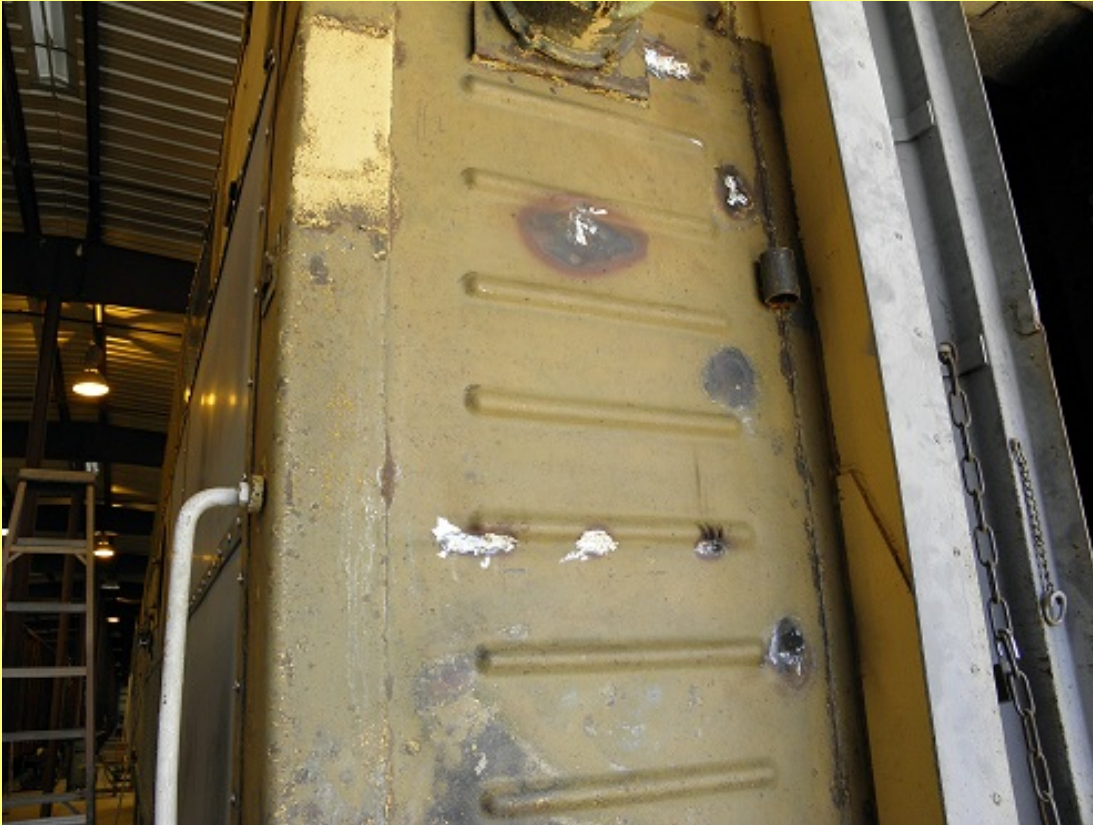
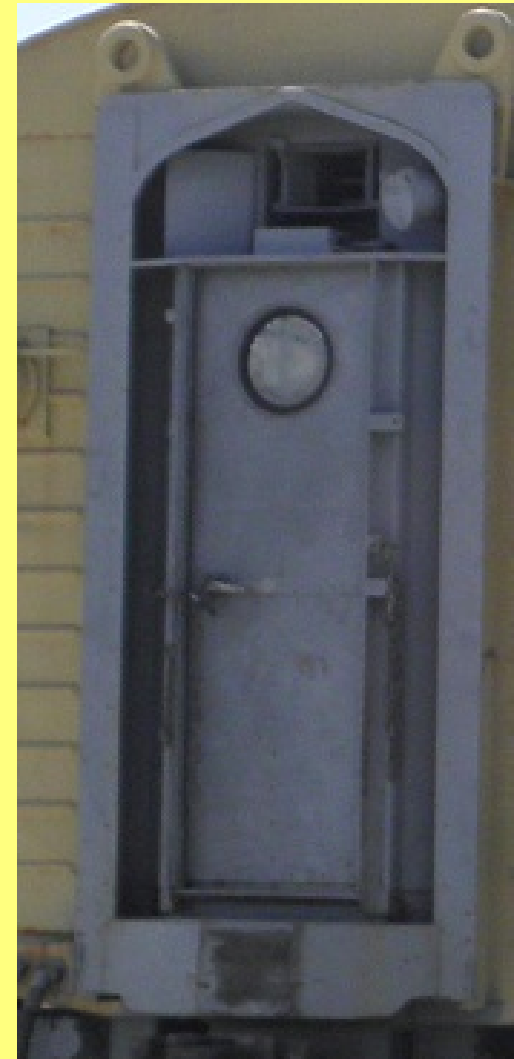
Another area that needed attention was the rear of the locomotive. The two main issues were the extremely poor condition of the rear door and removing the layers of old paint that had become chipped and cracked.

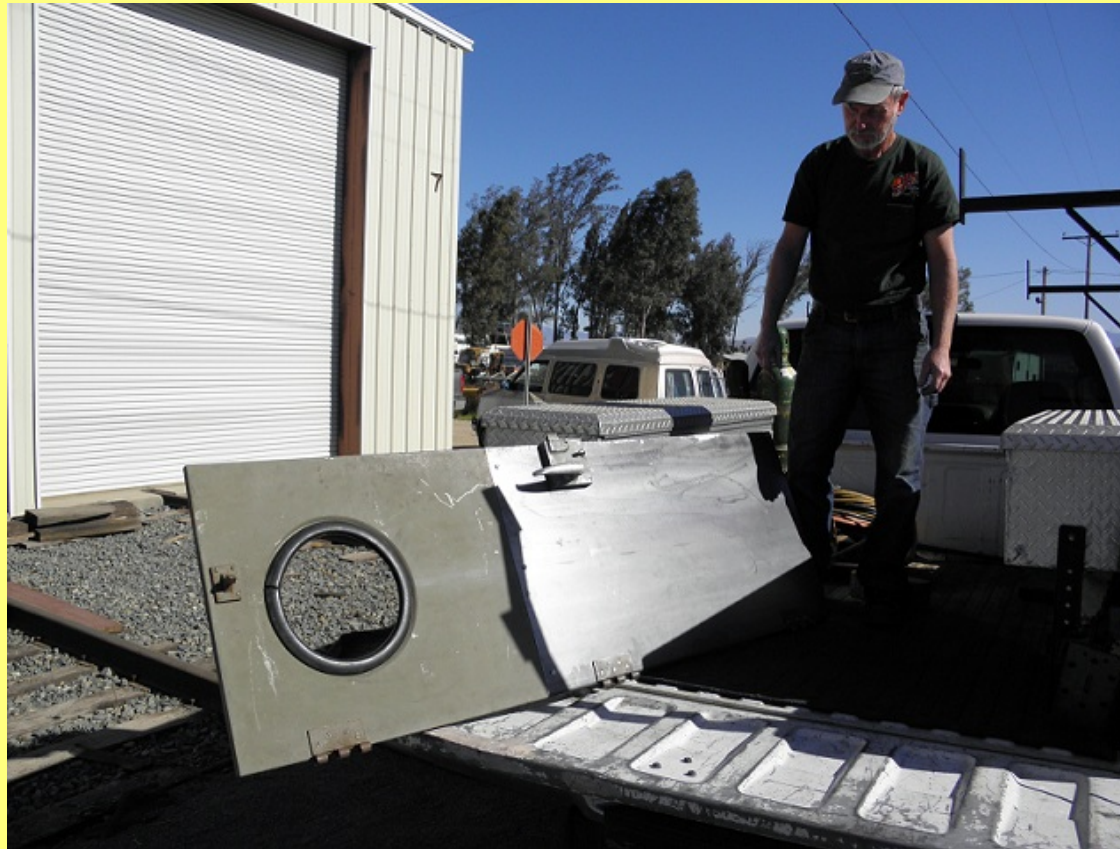
Even though cleaning the old paint from the rear end of U.P. 942 was tedious it was a pretty straight forward task. The rear door was a different story, however. After inspecting its condition there was no way around the fact that it needed to be completely rebuilt. Fortunately one of the diesel service crew, Carl Pickus, is very a very skilled metal craftsman and was recruited for the complex job.

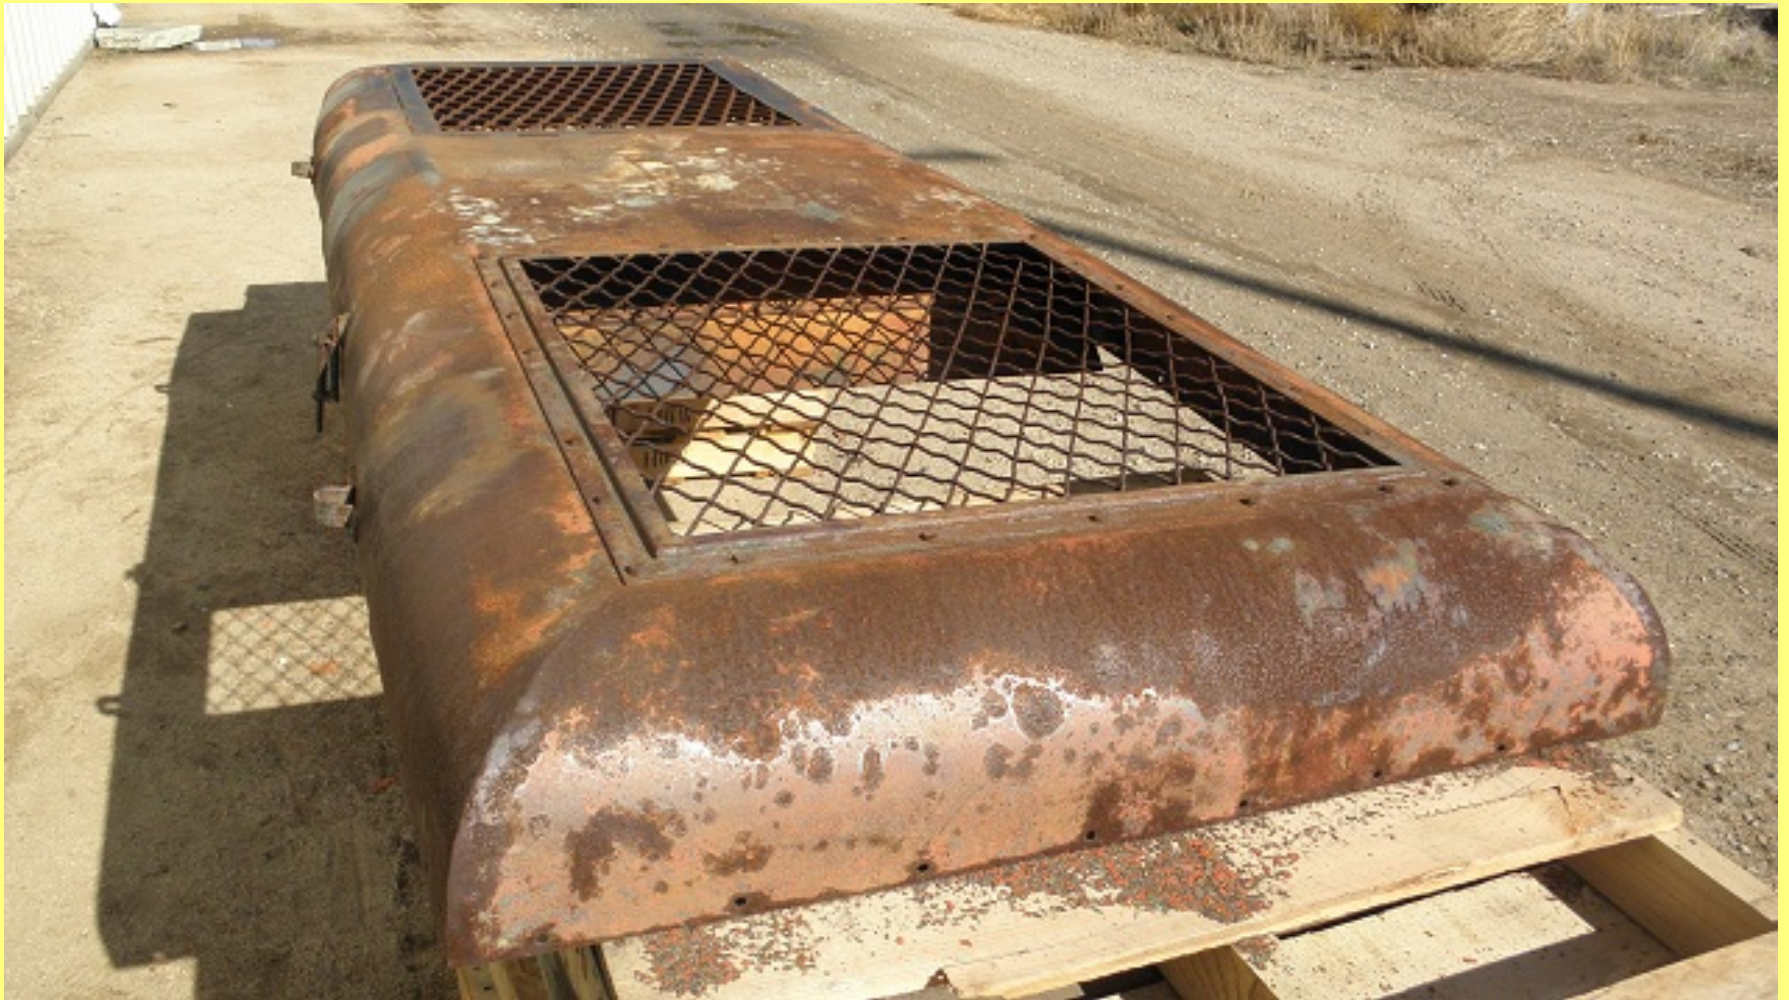
Here is one of the winterization hatches before being cleaned and readied for paint. This one has two openings, one of which will need to be covered before going up on U.P. 942.
