# Union Pacific E8 #942

Restoration project at Orange Empire  
Railway Museum Perris, CA  
2011/2012

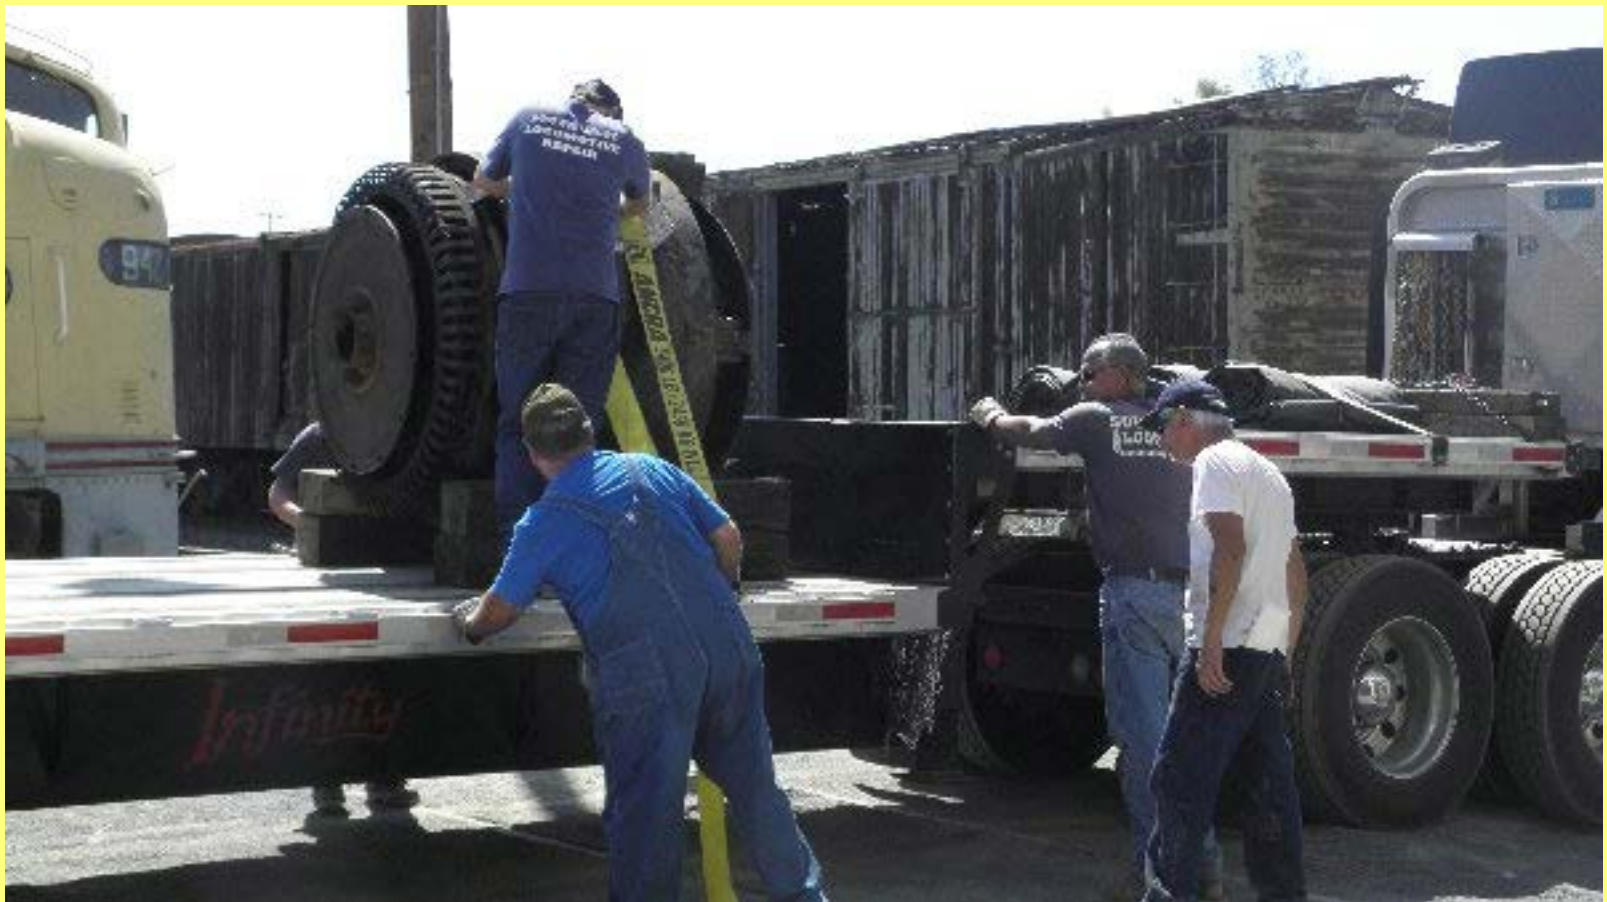
Here the generator is loaded onto a flatbed trailer and ready for the trip to Lyons, Kansas where it will be rebuilt. At this point the museum was not entirely sure of the extent of the damage and were hopeful that there wasn't enough wrong to prevent a successful rebuild.

Fortunately the generator did not provide any surprises and the rebuilder had the job done quickly. Here is the rebuilt generator waiting to be reinstalled.

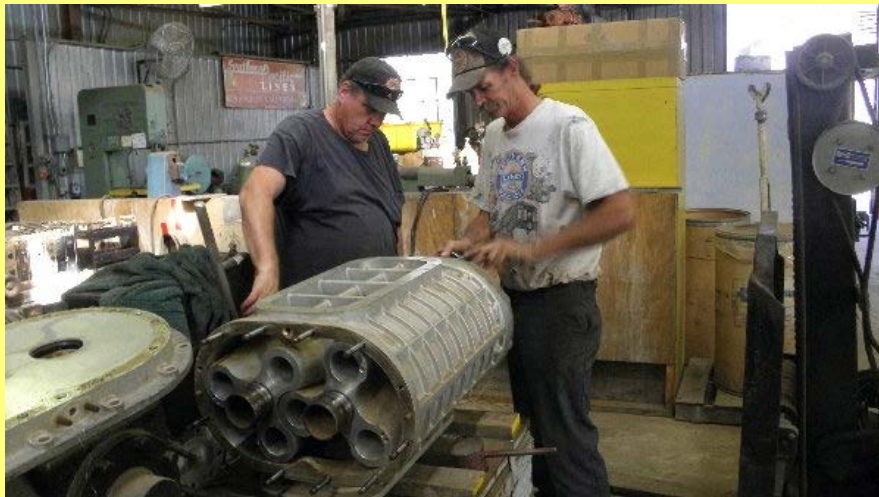
While the main generator was out a mechanical check revealed that the blowers that supply air to the prime movers were in poor shape. The museum had a spare set but they were not usable. Fortunately the museum has a volunteer who was able to arrange to exchange the blowers on hand for a rebuilt set in excellent condition.

Here Frank Kunsaitis and Dwayne Dame inspect the blowers that were on hand at OERM.

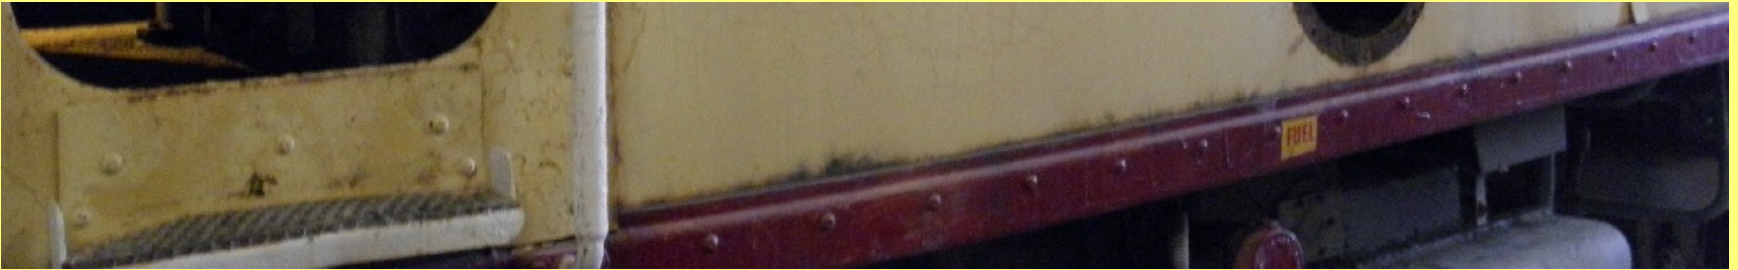
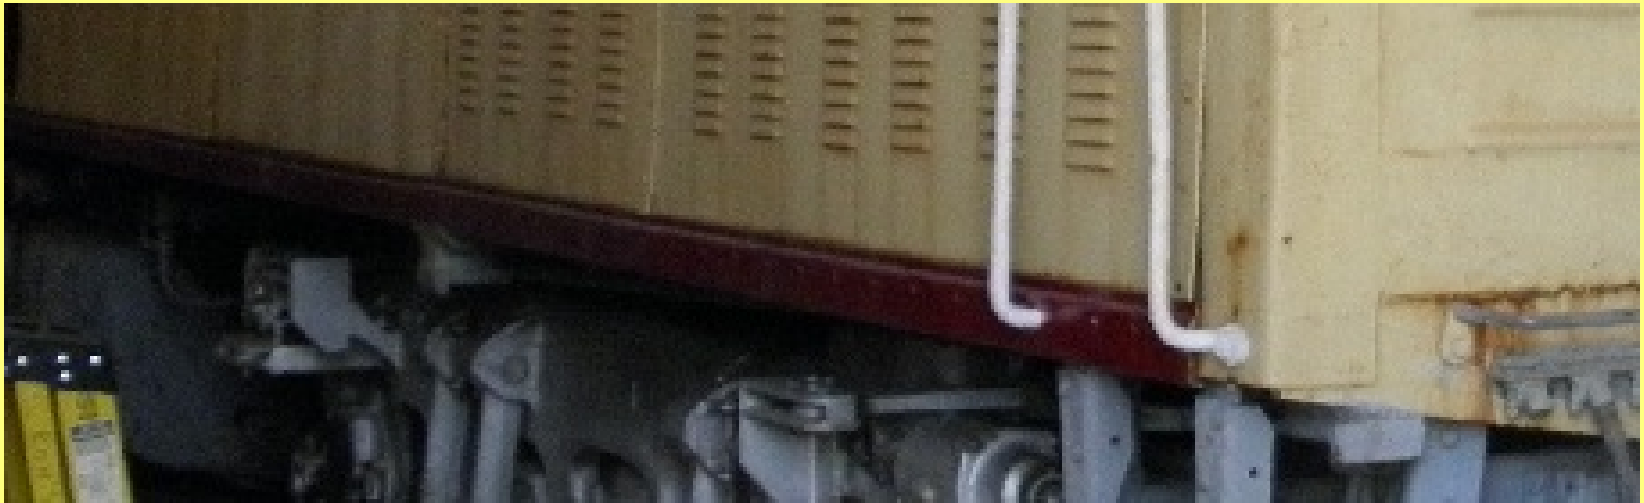
Along the bottom of both sides of the locomotive there is a “rub rail” that acts as a trim and more importantly helps hold the bottom row of body panels in place.

When U.P. 942 came to OERM the rub rail on both sides showed obvious signs of fatigue and we knew that when we removed these pieces it wasn't going to be pretty. So, we were not surprised when we found this.....

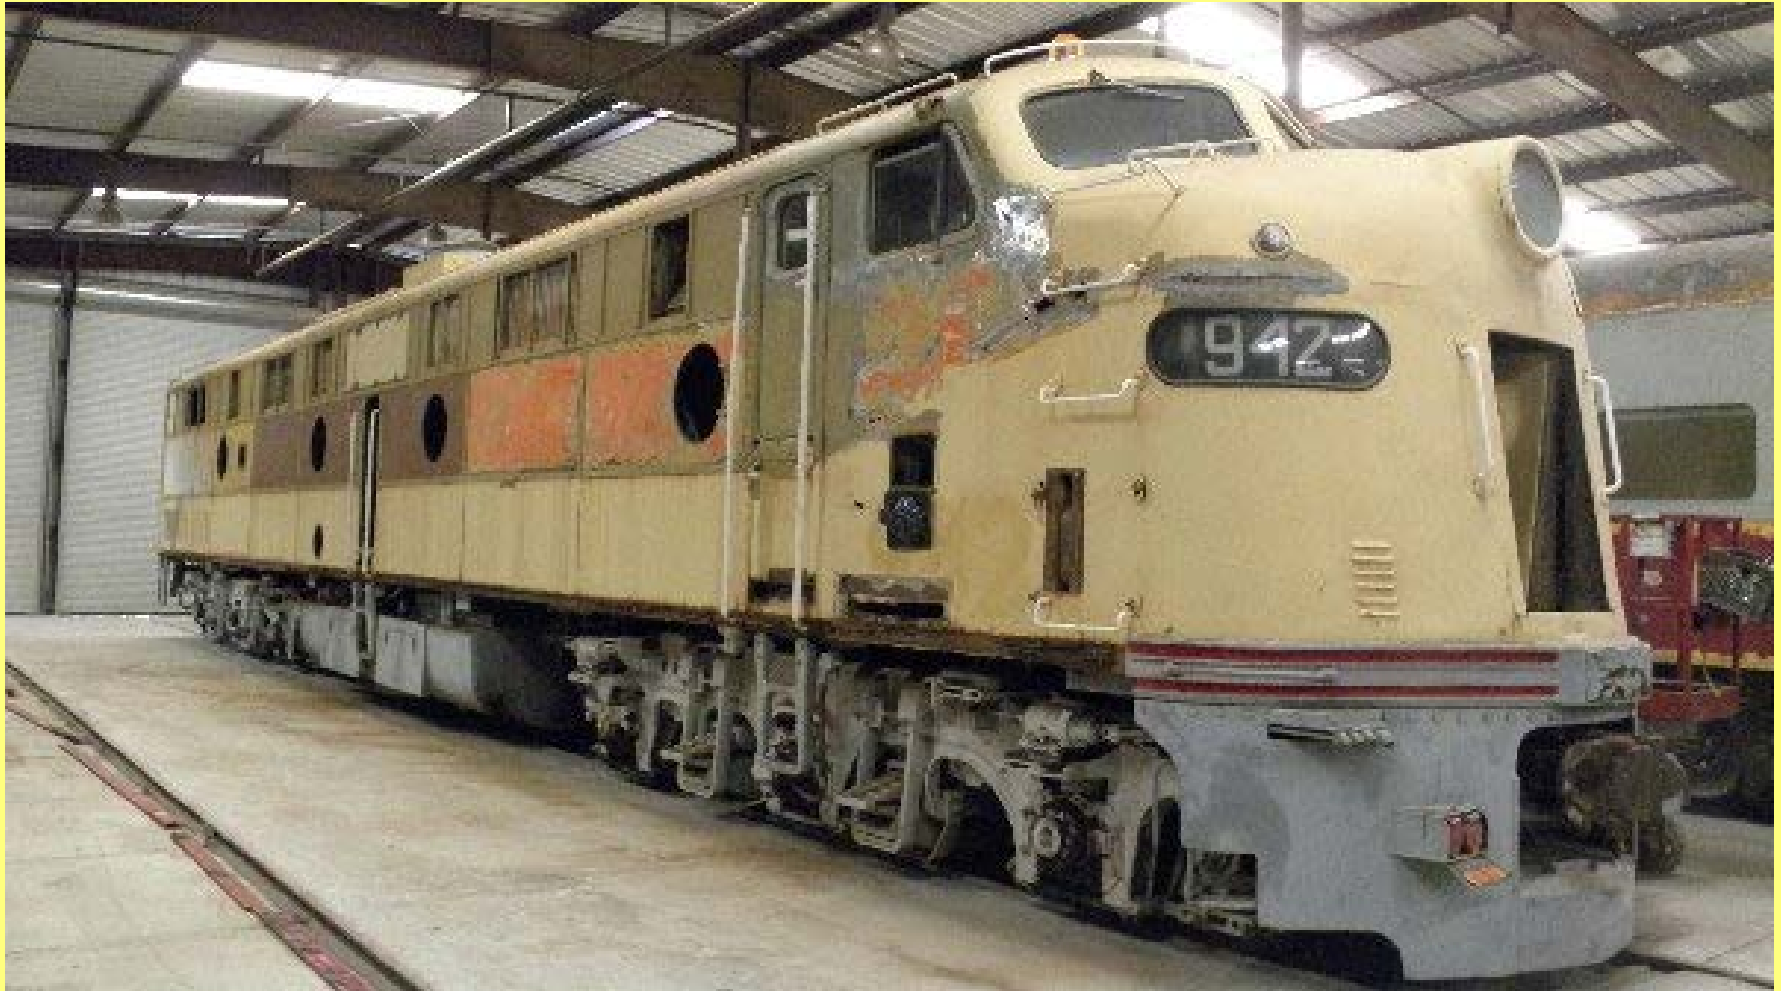
Underneath the rub rail sections there is a channel attached to the frame, which has threaded inserts used to bolt the rub rails to the locomotive. What was left of this channel was so badly rusted that there was no way to reuse it. Air chisels and elbow grease were used to remove the old channel so that new ones could be installed.

In this picture the rub rail has been completely removed from the engineers side. Before the end of the day the rusted channel will be cleaned off.

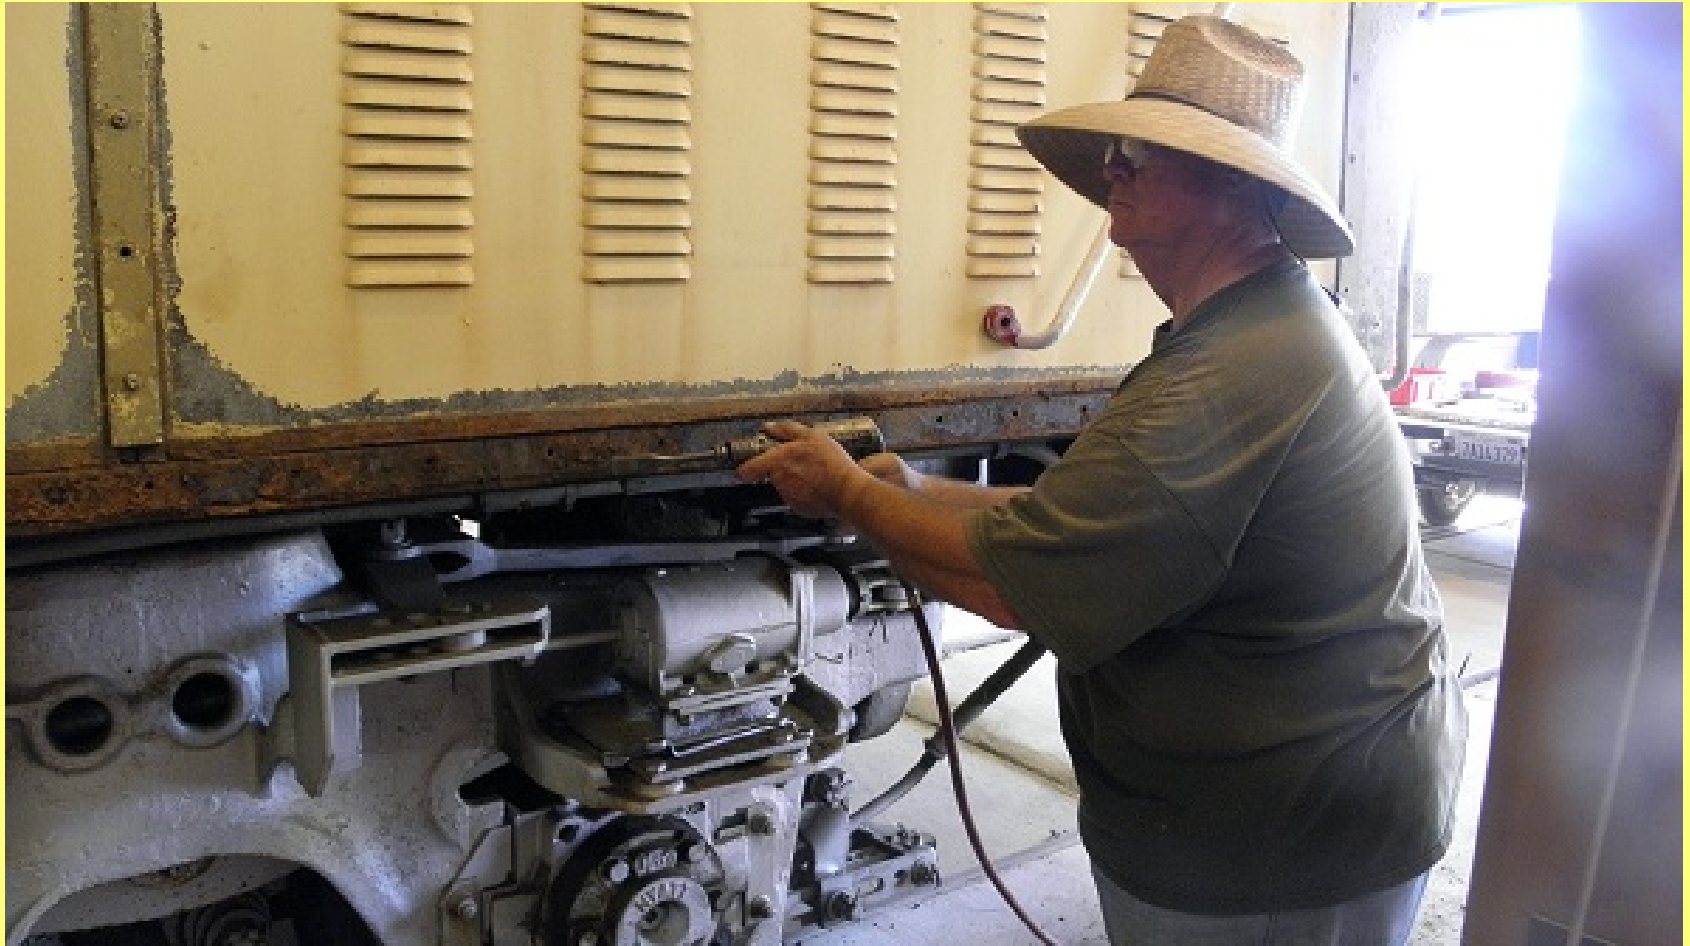
Since the old channel was in such bad shape it wasn't too difficult to remove. The best way to get the rusted metal off was by using an air chisel so car barn 7 was a noisy place to be when this was going on.

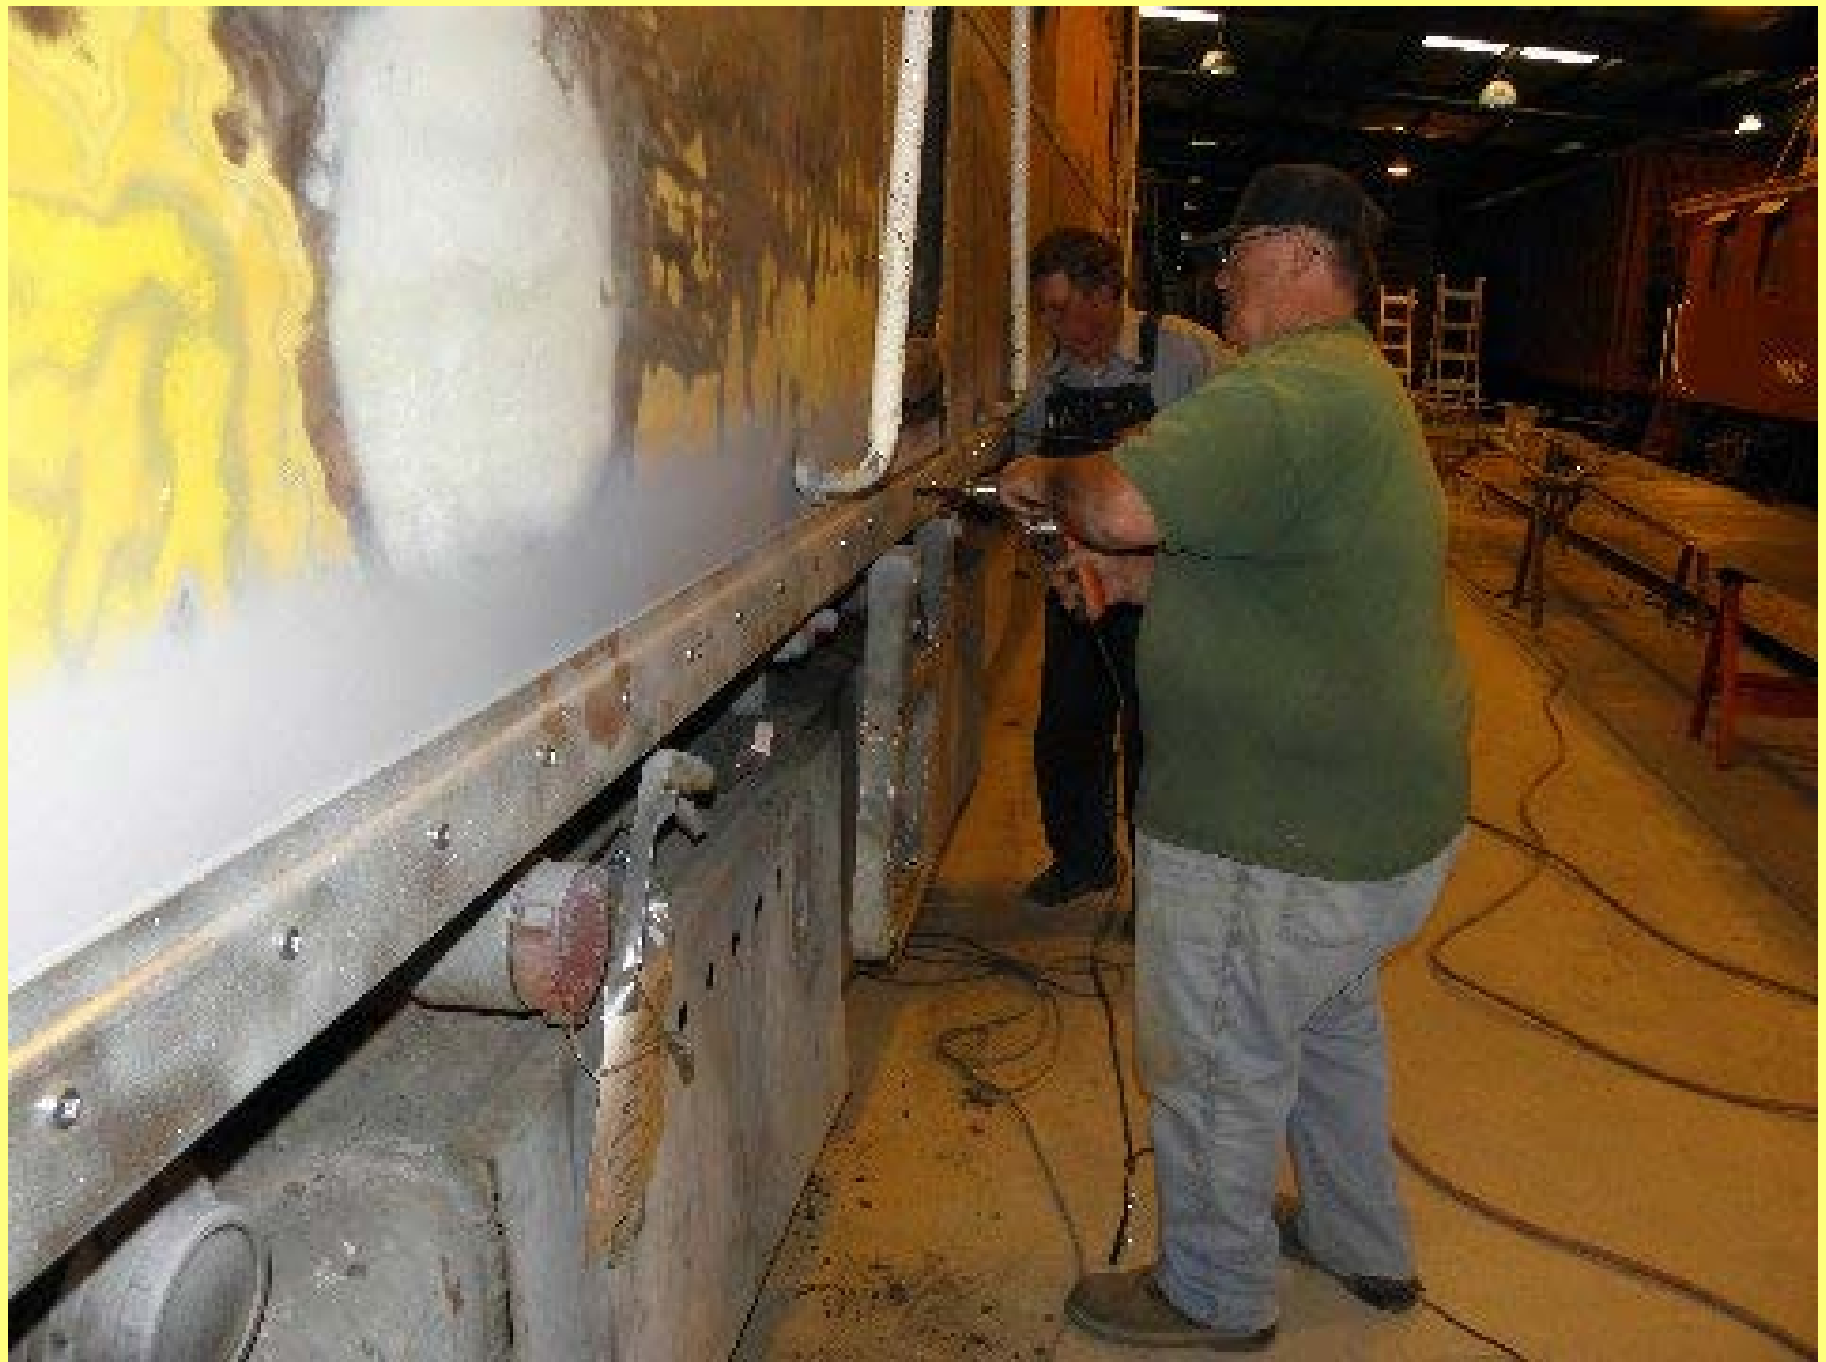
In a few cases there was old debris behind the new channel where the threaded inserts were located.

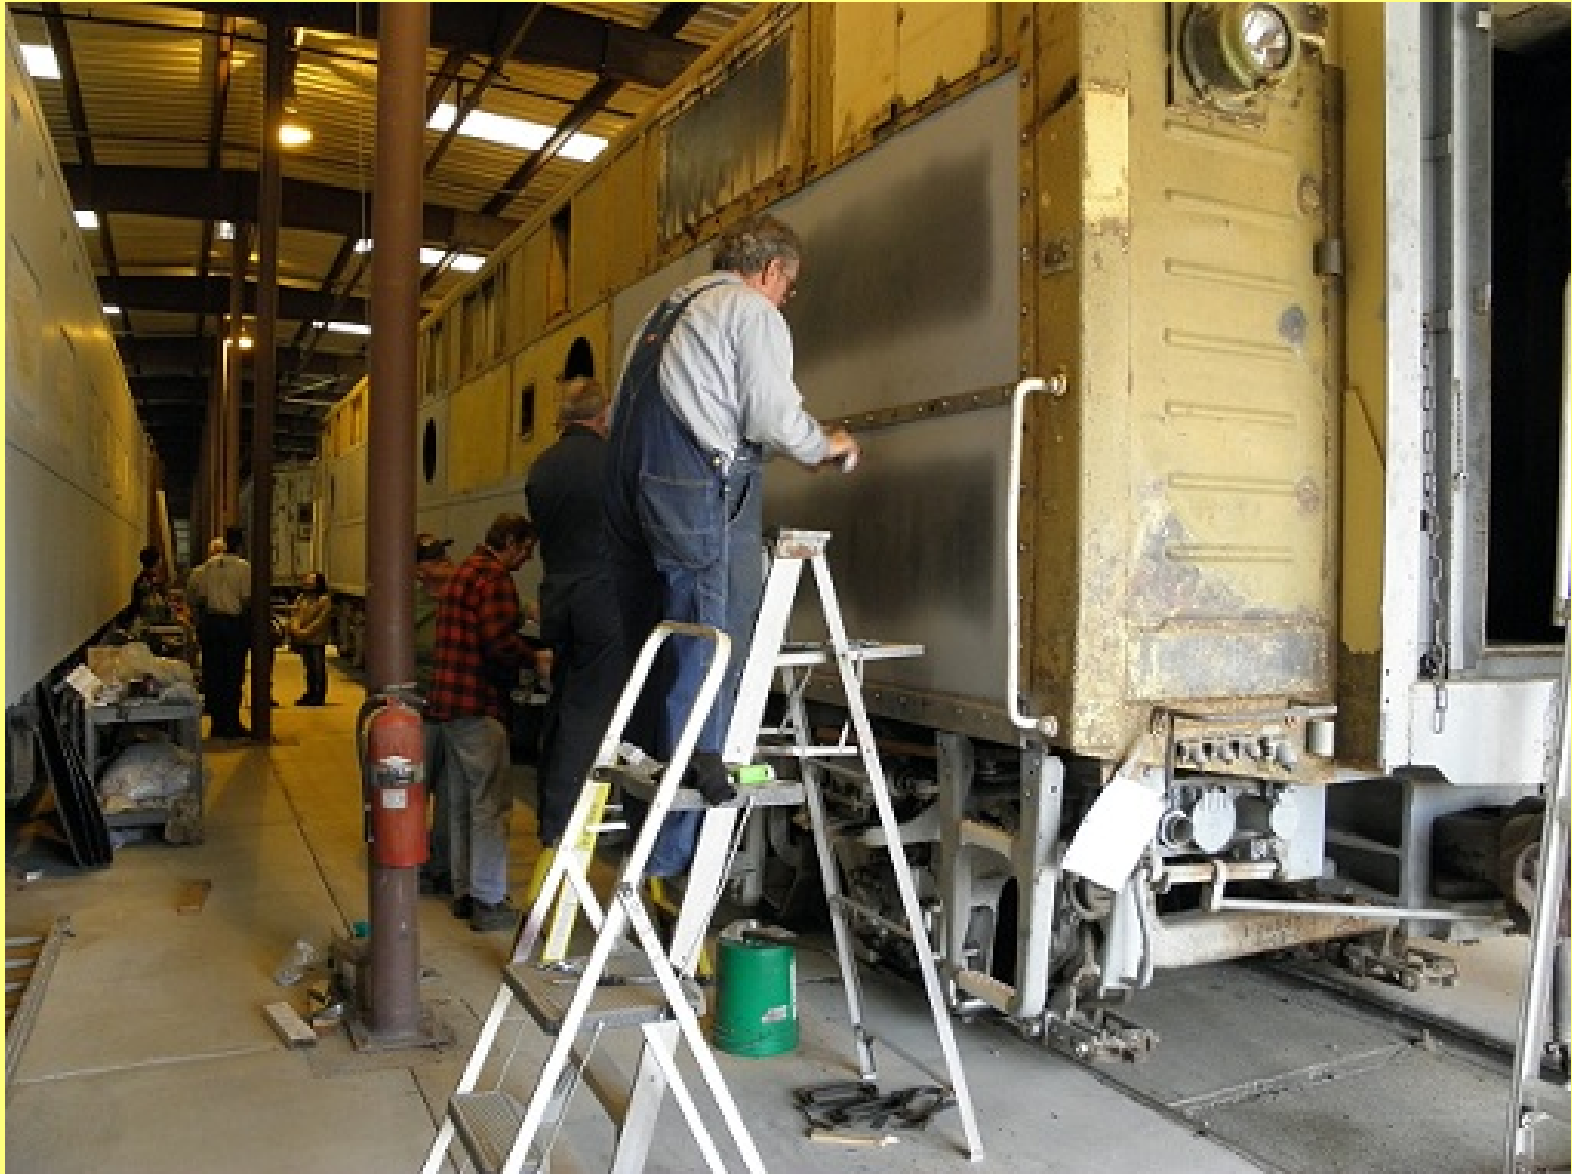
Originally the straps were held in place by bolts that went into threaded inserts, so at EMD it only required workers on the outside to install them. In many places these inserts on U.P. 942 were so rusted that they broke when we removed the bolts, so reinstalling the straps now required someone on the outside and the inside.

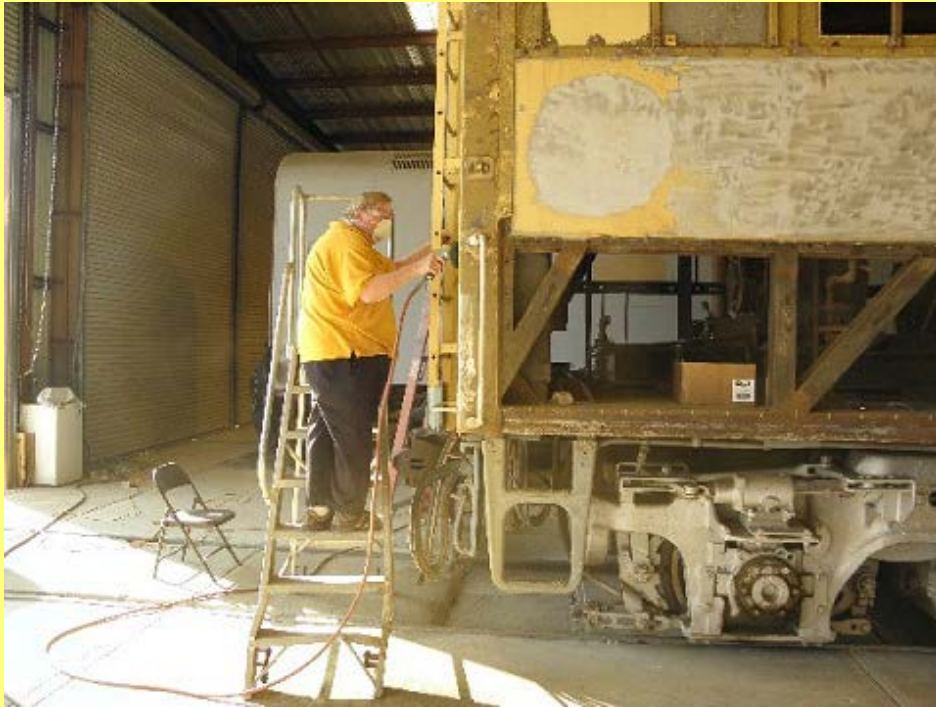
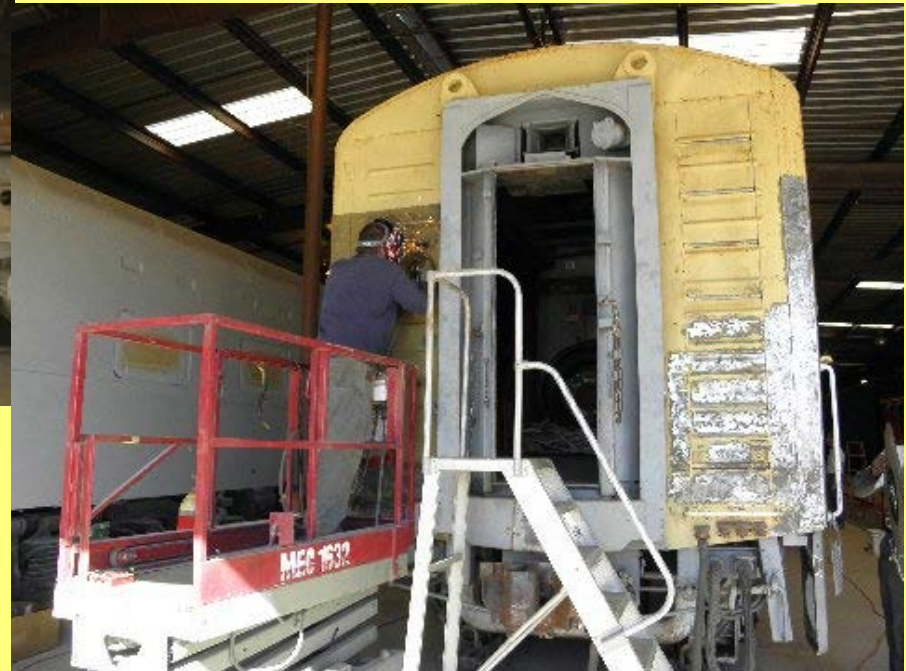
The ridges on the rear of U.P. 942 as well as the door frame made cleaning the metal a bit more difficult than on the sides and front of the locomotive.

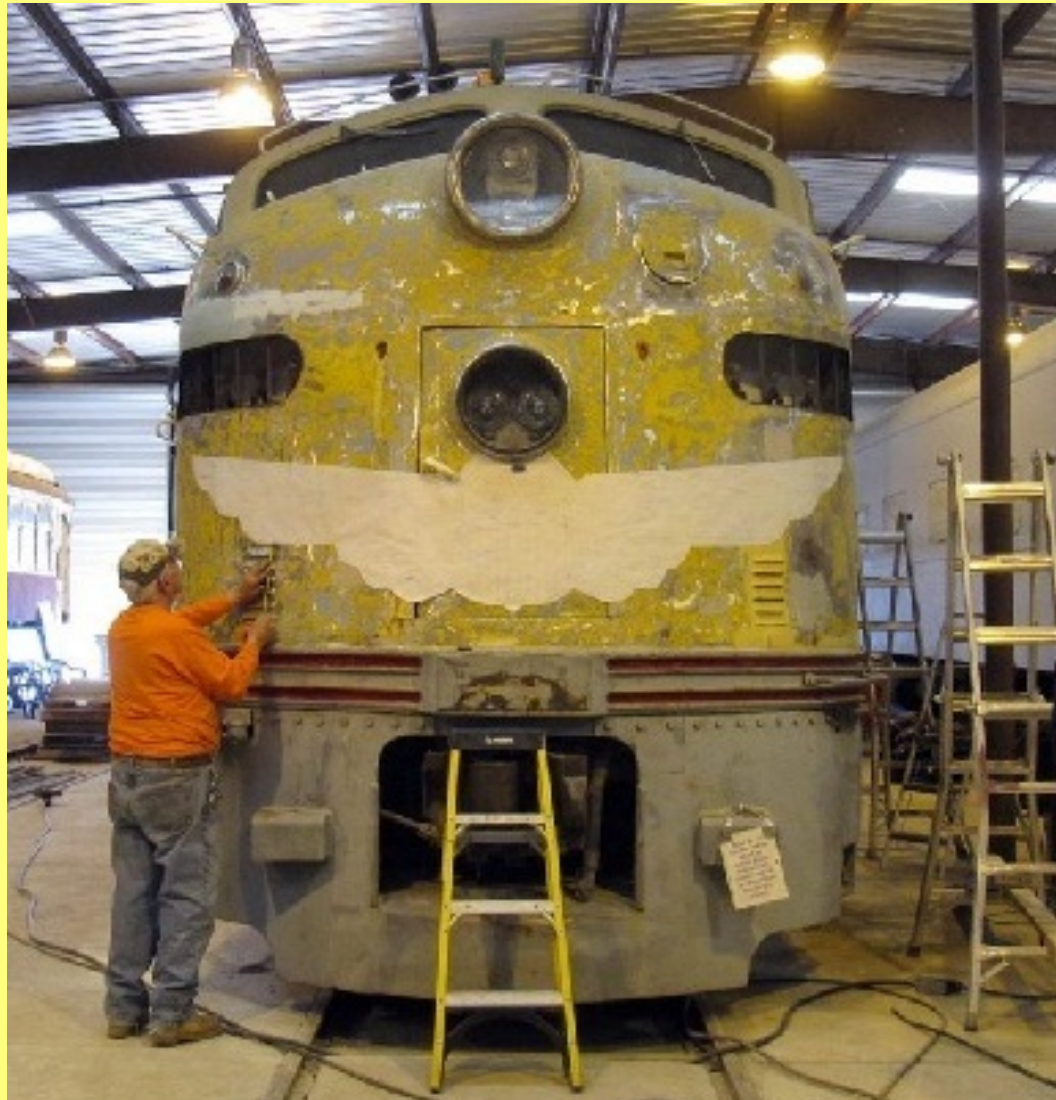
The first step in creating the emblem was to make a very accurate paper pattern and test fit it on U.P. 942. Since the company who was making the lettering and emblem needed plenty of time this was done before the locomotive had received primer.

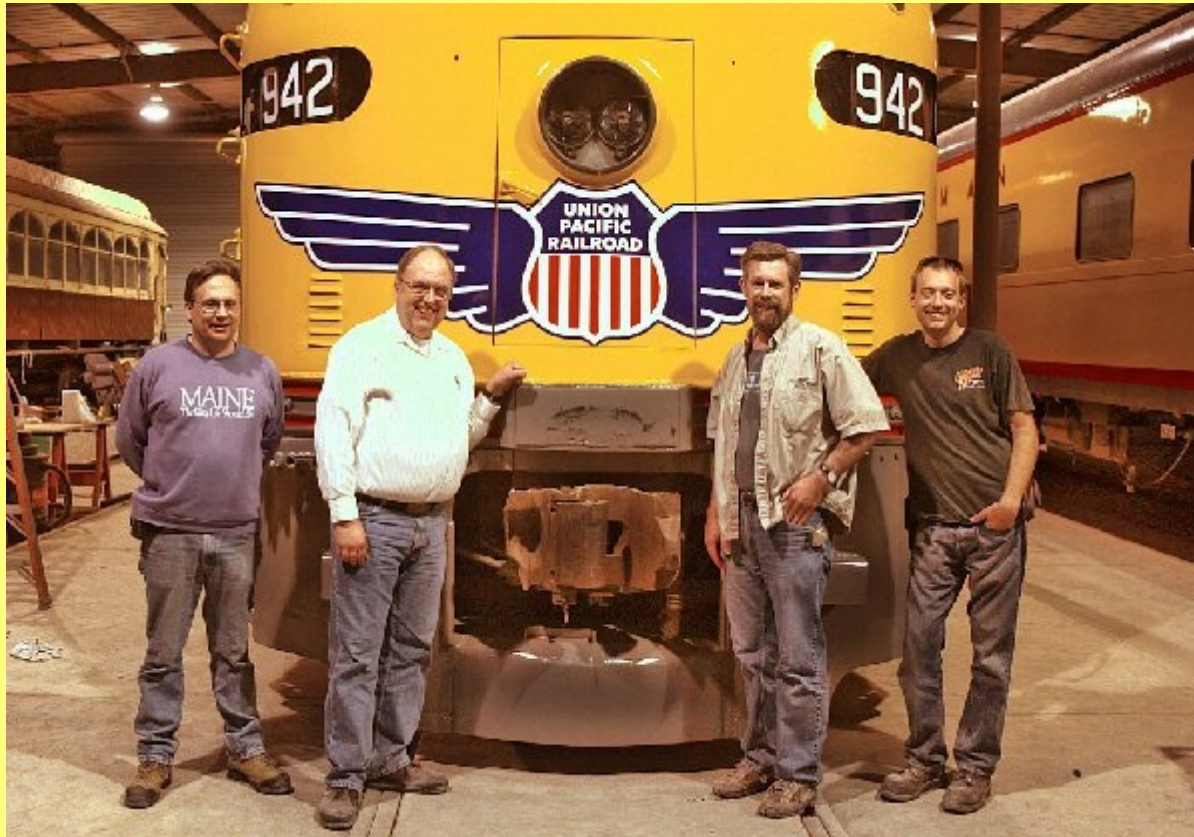
Time was running out quickly, so as soon as U.P. 942 was completely painted the lettering crew went to work.

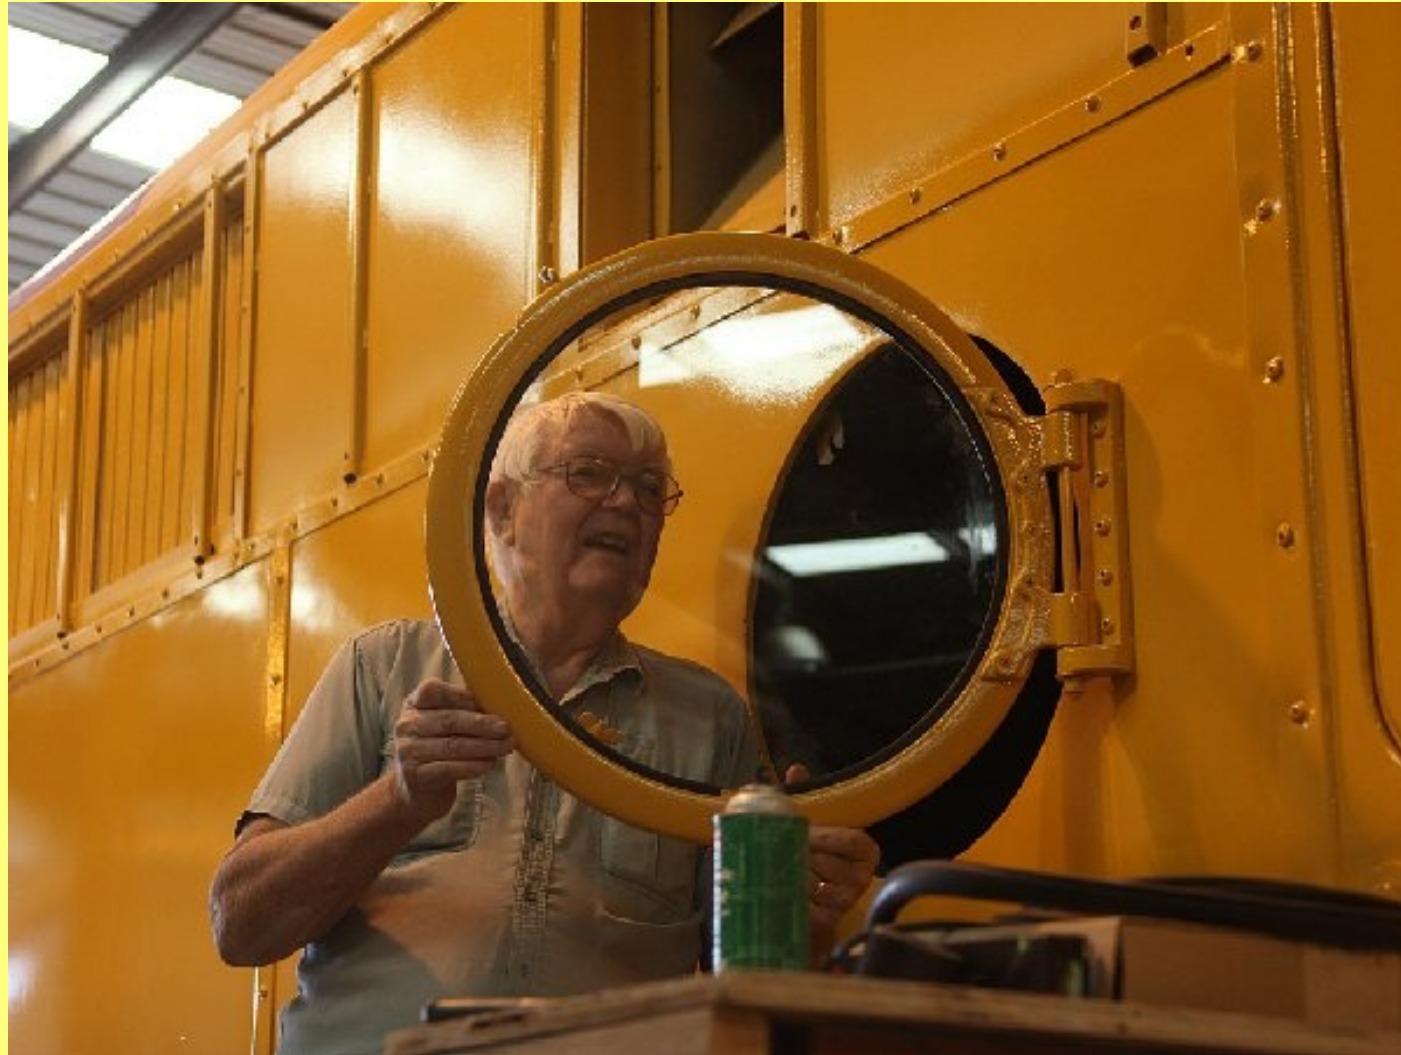
No attention to detail was spared on this project, even the cloudy old plexiglass in the porthole windows found on the sides of the locomotive were replaced with actual safety glass.

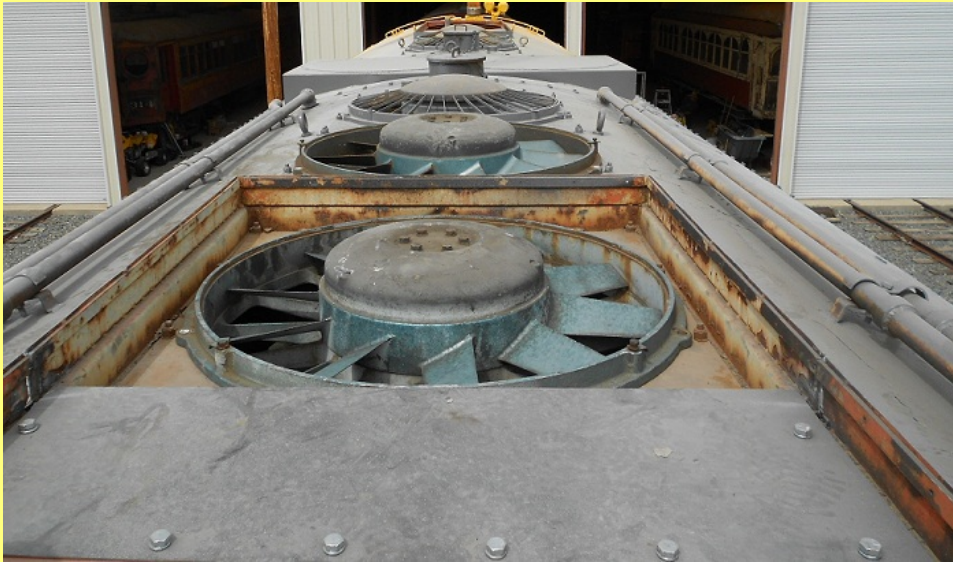
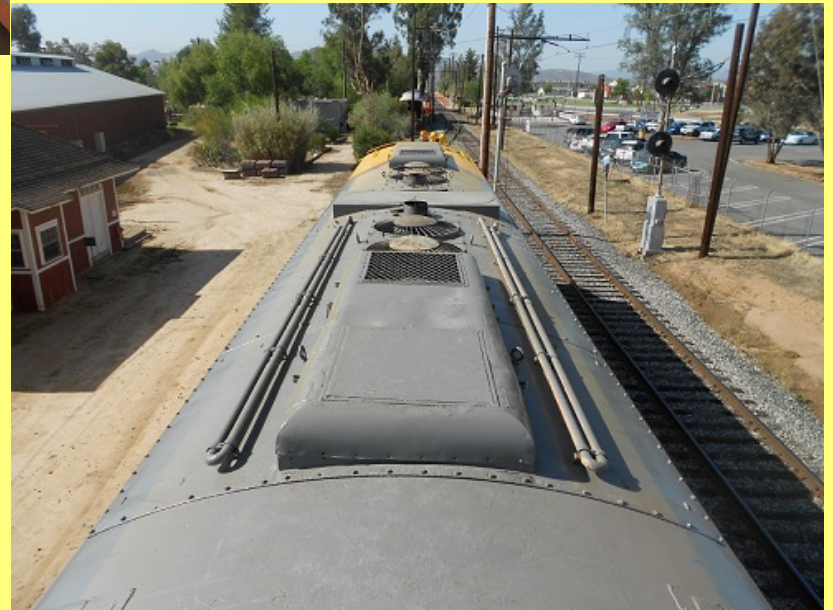
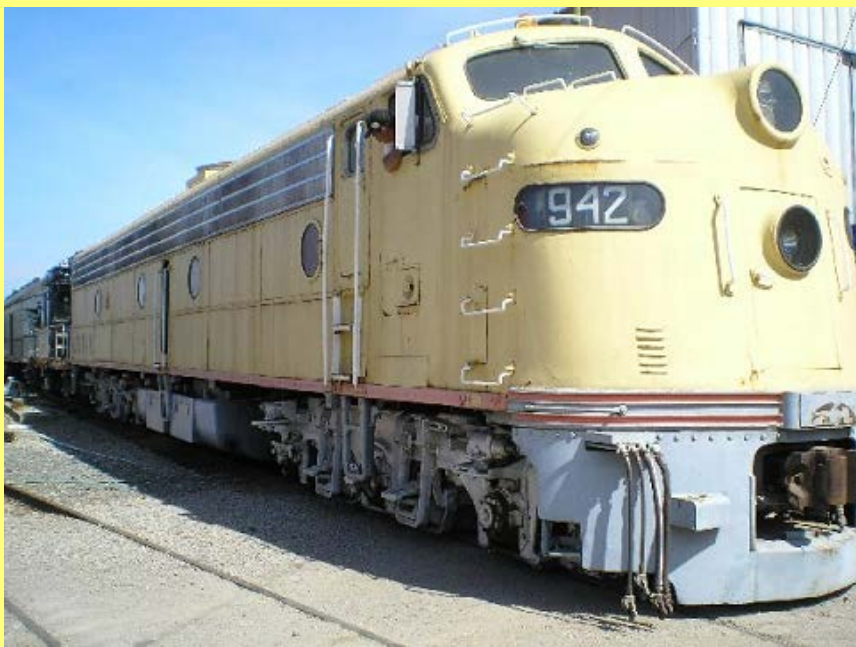
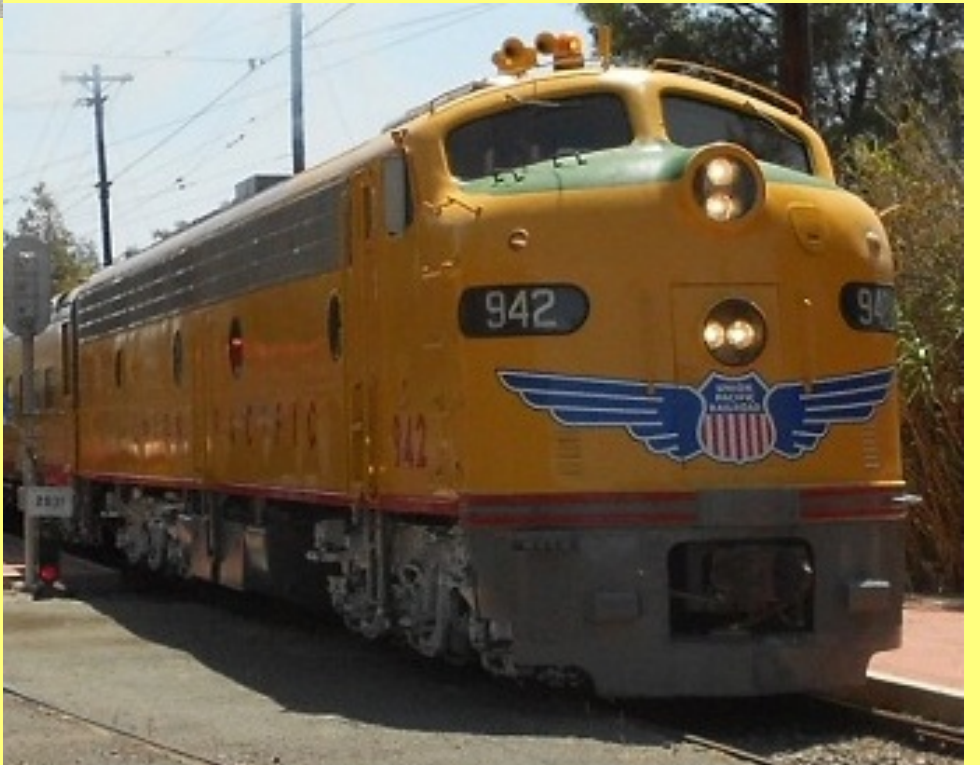
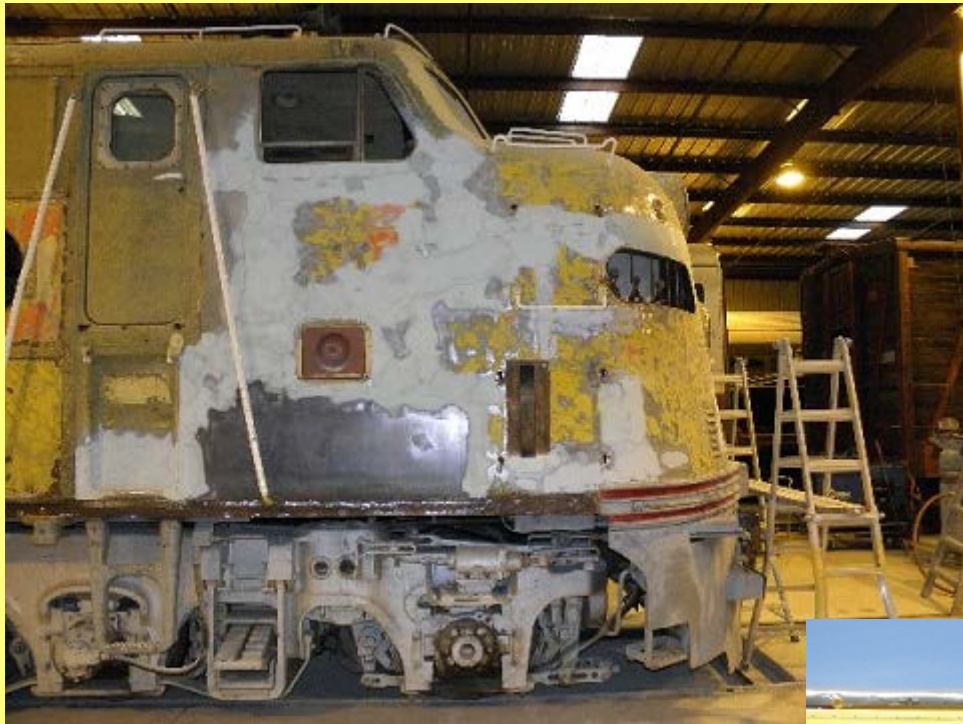
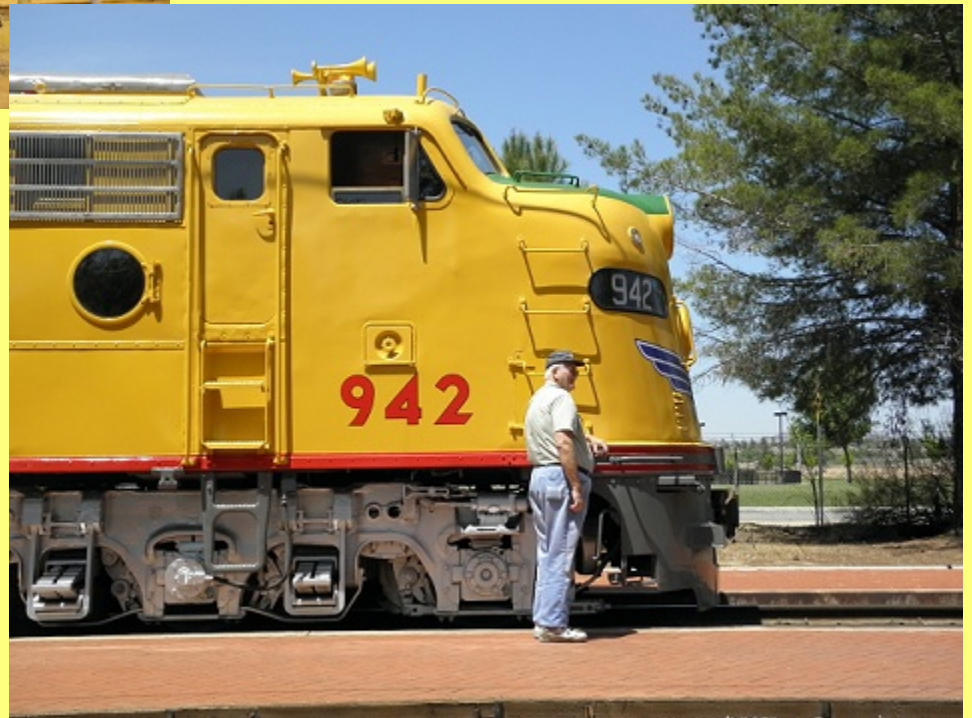
The day we had worked for was here at last!!  
Here are some comparison pictures to show what had been accomplished.
