Nostalgia & History

What is the item the two men are on? Picture 1 and 2 are from the website, http://contentdm.lib.byu.edu/cdm/singleitem/collection/GEA/id/3884/rec/160

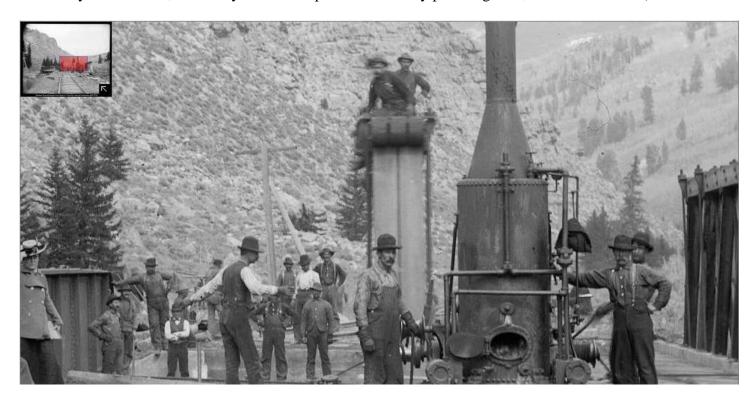
Picture 1, Enlarged 80%. Call Number: MSS P-3156 # 29. Title: Schumans Bridge Crew Bridge. Photographer: Anderson, George Edw 1860-1928. Contributor: Edwards, Robert W. (Robert William), 1925-2002. Description: A photograph taken outdoors of a group of m working on a railroad bridge with two women seated looking at the camera. Date: ca. 1880-1920. L. Tom Perry Special Collections, H Lee Library, Brigham Young University. Place: Hale, Utah. Physical Description: Gelatin dry plate negative; 20.32 x 25.4 cm. (8 x 10

I think they are sitting on the left side of the wooden bridge that is being dragged by the steam donkey (winch) out of the way.

The tower with the two men on it across the stream is a mystery. [Edit: Yes, perhaps it is part of the old bridge.]

The machine on the near bank is a donkey engine, widely used by loggers and contractors as a winch. It appears to have a single ho spool. Cylinders for the engine can be seen on each side of the base of the boiler, and behind that the shaft of the winch can be seen out on each side with spools for rope. The one on the right is wound with rope on it now.

The newly assembled steel plate girder bridge on the left is about to be slid into place, and an old wooden truss has already been slid the right side out of the way. Both bridges rest on temporary wooden skidways.

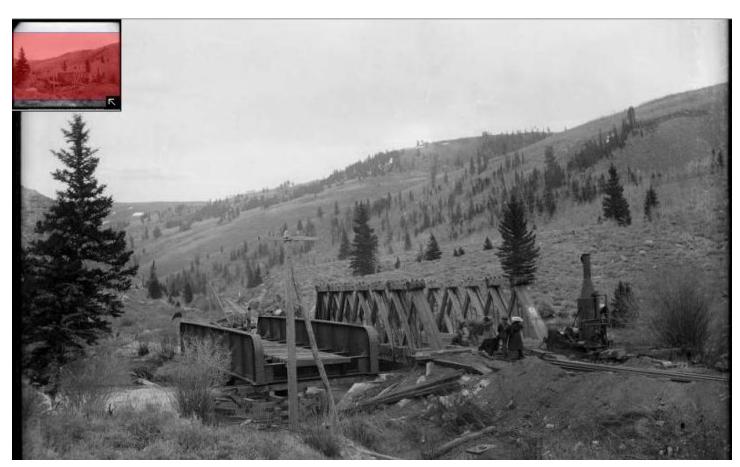
Picture 7, "Call Number: MSS P-3156 # 26. Title: Schuman's Bridge Crew at Bridge. Photographer: Anderson, George Edward, 1860- Contributor: Edwards, Robert W. (Robert William), 1925-2002. Description: A photograph taken outdoors of three men and two wom standing on or near a railroad bridge under construction. Date: ca. 1880-1920. L. Tom Perry Special Collections, Harold B. Lee Librar Brigham Young University. Place: Hale, Utah. Physical Description: Gelatin dry plate negative; 20.32 x 25.4 cm. (8 x 10 in.)."

From these additional pictures it appears that nicknack and LarryDole are correct, the two men are sitting on the left side of the woo bridge and that the steam donkey is dragging the wooden bridge out of position and the metal bridge into position on the tracks.

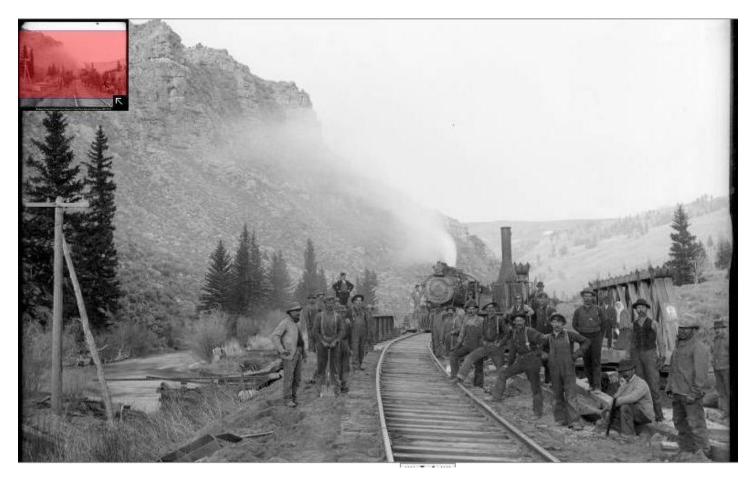
Picture 9, Finished. "Call Number: MSS P-3156 # 31. Title: Schuman Bridge Crew. Photographer: Anderson, George Edward, 1860-1 Contributor: Edwards, Robert W. (Robert William), 1925-2002. Description: A photograph taken outdoors of a number of men and on woman looking at the camera, standing on either side of railroad tracks which run across a bridge on which is standing a locomotive. ca. 1880-1920. L. Tom Perry Special Collections, Harold B. Lee Library, Brigham Young University. Place: Hale, Utah. Physical Descrip Gelatin dry plate negative; 20.32 x 25.4 cm. (8 x 10 in.)."

The occasion of the photo was the completion of a steel bridge to replace the adjacent wooden bridge at the location. The trackage surrounding the dam was washed out in the 1917 Mammoth dam failure, but was repaired. The steel bridge is still there, and is used coal trains today. The bridge is about 6.4 miles west of Colton, and about 3.6 miles below Scofield Dam (about 8.9 miles from Scofiel

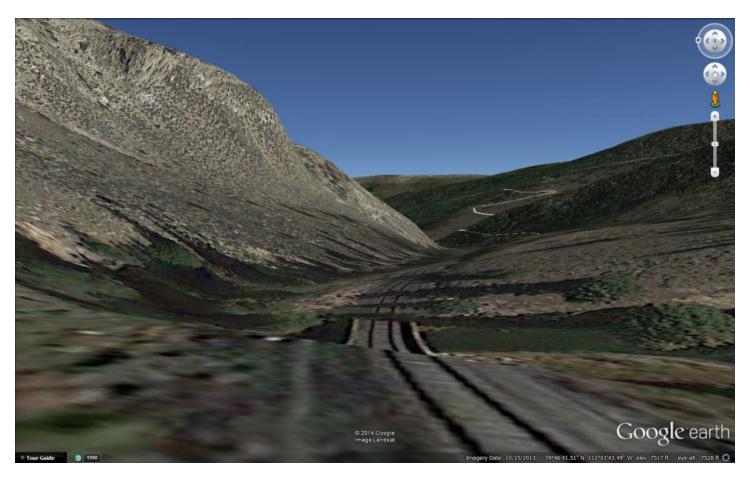
Here is a Google Earth view showing the similarity of the geographic layout of the canyon in that vicinity.
